AMERICAN
STRUCTUREPOINT
INC.

CASE STUDY

BARN COLLAPSE; WHEN EXPERIENCE IS NOT ON YOUR SIDE

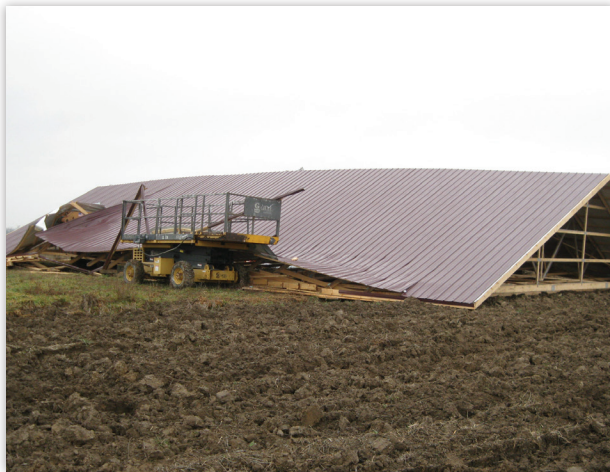
Even though the collapse of the barn occurred during an atypical November thunderstorm, a brief view of the barn collapse debris revealed the mode of failure was not solely the result of elevated wind speeds. According to the National Weather Service, the moderately severe storm produced a maximum sustained wind speed of 36 mph and maximum wind gusts up to 45 mph from the west, as recorded approximately 10 miles southeast of the property in rural northeast Indiana. These wind speeds are common in the region and are typically achieved several times each year.

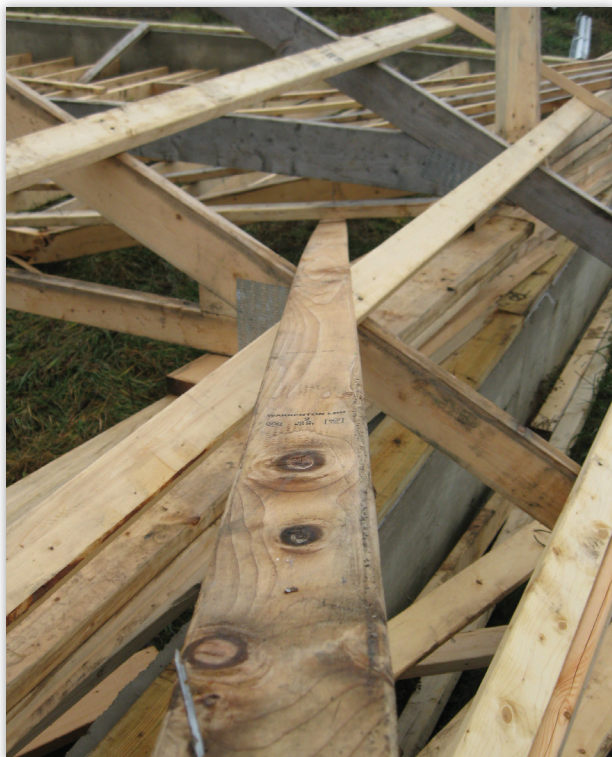
The rectangular barn was approximately 40 feet by 80 feet (long dimension in the east-west direction) and was constructed of common wood framing with wood roof trusses supported by wood stud walls that stood on short concrete foundation walls. The wood-framed barn was situated in an open field and was approximately 70 percent complete at the time of the collapse, lacking wall siding and approximately 25 percent of the metal roofing.

Based on the configuration of the collapsed debris, the walls and roof trusses fell approximately 15 feet directly to the east, appearing to be pushed over by the westerly wind. The system of roof trusses contained sufficient bracing and remained relatively undamaged as the building rotated and collapsed. The 40-foot east and west walls were generally still intact after falling over to the east. In a domino effect, the individual studs of the 80-foot-long north and south walls were laid over in the plane of the walls. In general, the wall studs were relatively undamaged as they lay on the ground following the collapse.

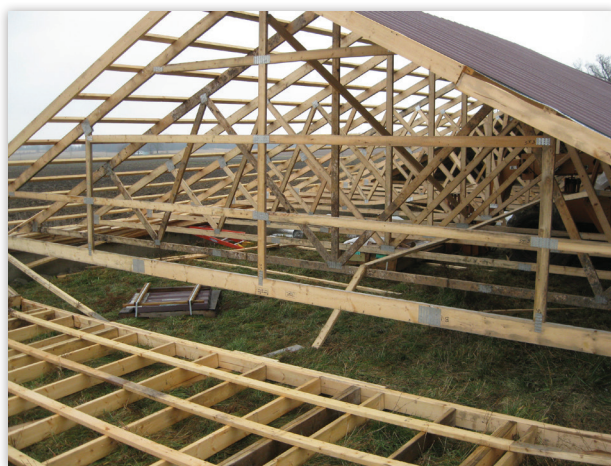
braced by two wood 2x4's in the plane of the wall. The braces were orientated from the top corners down toward the base of the wall at an angle of approximately 45 degrees. The 20-foot-long wall braces were nailed to the adjacent wall studs at both ends of the brace and periodically along the length of the brace. Nail spacing of the braces was inconsistent and varied from 32 inches up to 13 feet. The braces at the west side of the long north and south walls were fractured near the middle of the braces. The fractures were consistent with the braces buckling in compression. No nails were located in the vicinity of the fracture. The braces located at the east end of the long north and south walls were not significantly damaged as the nails were pulled from the structural members, which was consistent with the braces being loaded in tension, as expected.

While the completed structure would have likely performed better during the moderate wind event, it is the construction contractor's responsibility to ensure a building is structurally stable throughout the construction process. However, our forensic study revealed the 2x4 in-plane wall bracing with periodic nailing did not have the structural capacity to resist the horizontal loads from the moderate wind speeds that were sustained. This mode of failure is substantiated by the observation of bracing that was buckled and fractured in compression at the west end of the building and the tensile failure of the bracing at the east end of the building.

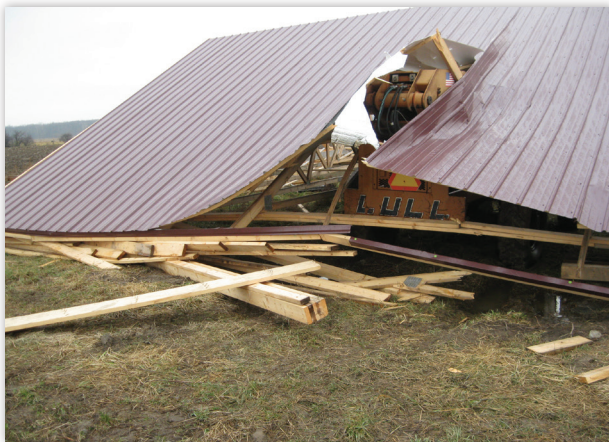
horizontal forces to the foundation. In the case of westerly winds being resisted by the braces in the north and south walls, compressive forces develop in the bracing at the west end of the walls and tensile forces develop in the bracing at the east end of the walls. The resistance capacity of the braces is dependent on many factors, including the material, width, depth, and length of the brace element, as well as how and where the brace is nailed to the adjacent wall studs. The frequency of nailing of the braces is crucial to the resistance capacity of long and relatively flimsy 2x4 braces. In effect, the wall studs brace the braces. Nailing a compression brace to each adjacent wall stud ensures a high compressive stress can be resisted by the brace before it fails. Not nailing

a compression brace to each adjacent wall stud significantly reduces its capacity to the point where the long and flimsy brace easily kicks out of plane and buckles in compression as was observed. When the compression braces suddenly fail, the entire wind load must be resisted by the tension braces. In this case, the entire wind load that was transferred to the tension braces resulted in failure of the connection between the tension braces and the wall studs.
