## WIND DAMAGE OR IMPROPER SHINGLE INSTALLATION

### THE IMPORTANCE OF CORRECT FASTENER PLACEMENT

Author: Doug Brown, PE, RRC – Investigative Group Operations Manager, American Structurepoint

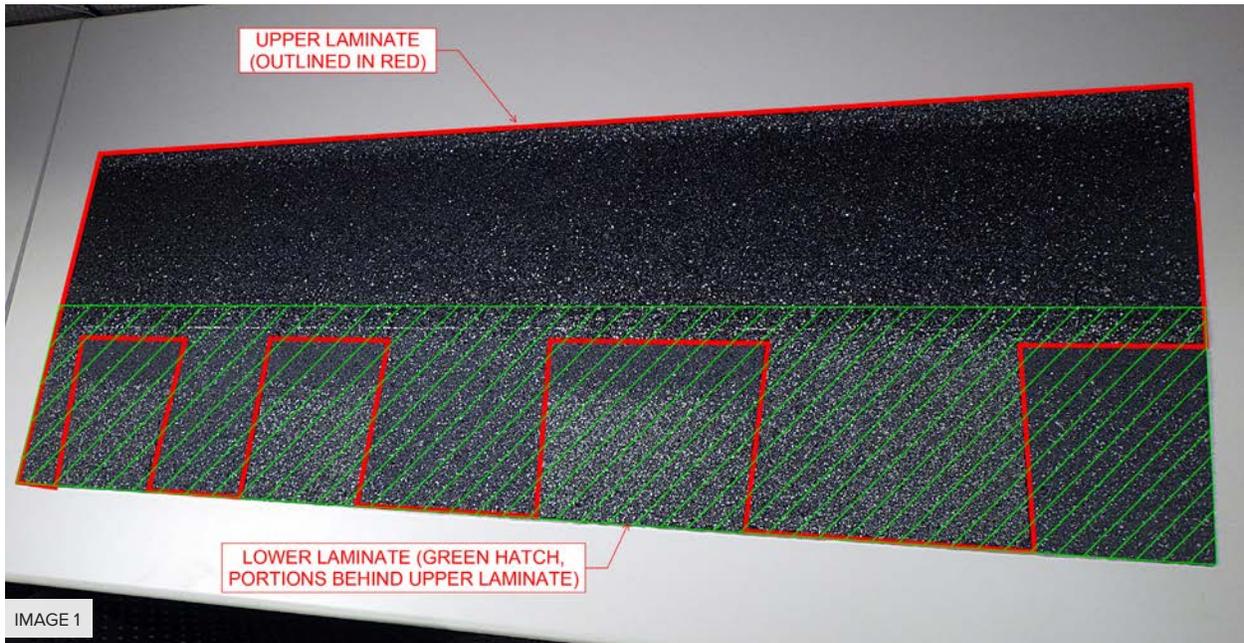
The upper laminate, or sawtooth section, typically extends the full shingle height (commonly ranging from 12 inches to 13.25 inches), with cutouts in the lower, exposed portion of the shingle to create the “sawtooth” or “dragon tooth” appearance (see Image 1).

The rectangular-shaped lower laminate, or backer strip section, extends from the base of the shingle to approximately mid-height of the shingle (Image 1). The lower laminate is adhered to the saw teeth and along the narrow band where the fasteners are intended to be placed, commonly identified as the nailable area (Image 2).

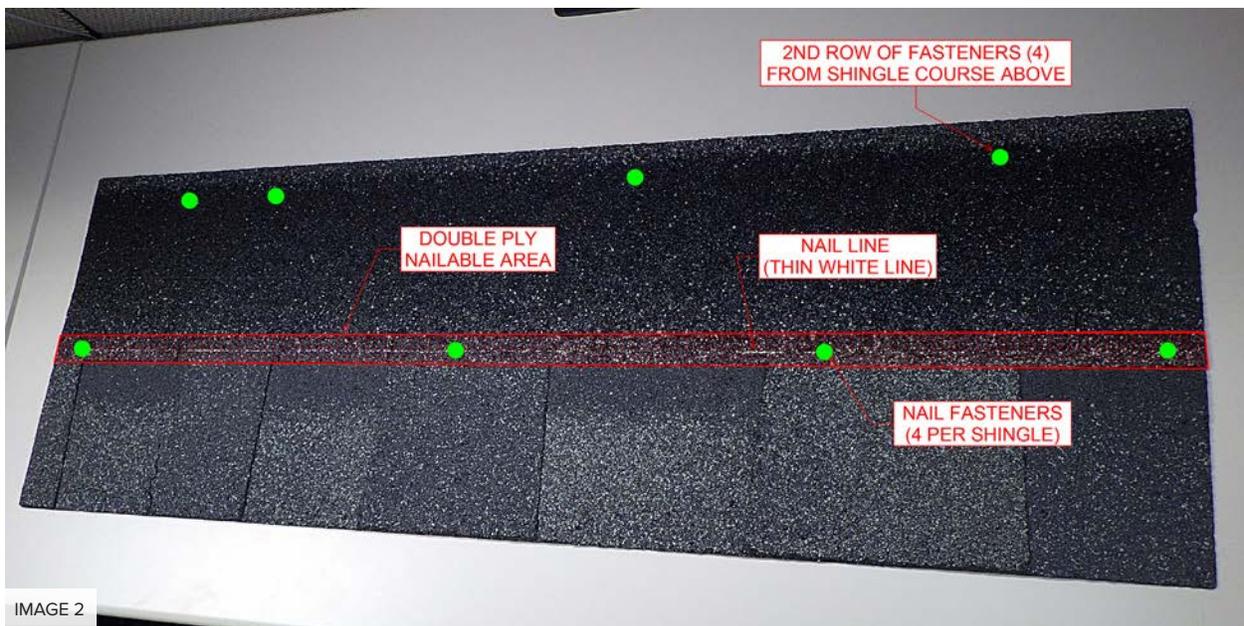
Standard shingle installation includes four fasteners per shingle within the nailable area, with fasteners approximately one inch from each end and the remaining two fasteners near the one-third points (Image 2). With the shingles installed in an overlapping fashion, each shingle will end up with a second row of fasteners attaching them to the roof deck and, therefore, eight total fasteners per shingle (Image 2).

For laminated shingles to be properly fastened to the roof deck, the four fasteners must be installed within the double-ply nailable area, a narrow band across the shingle typically 0.5 to 1.5 inches wide where the upper and lower laminate overlap, located immediately above the saw teeth (Image 2).

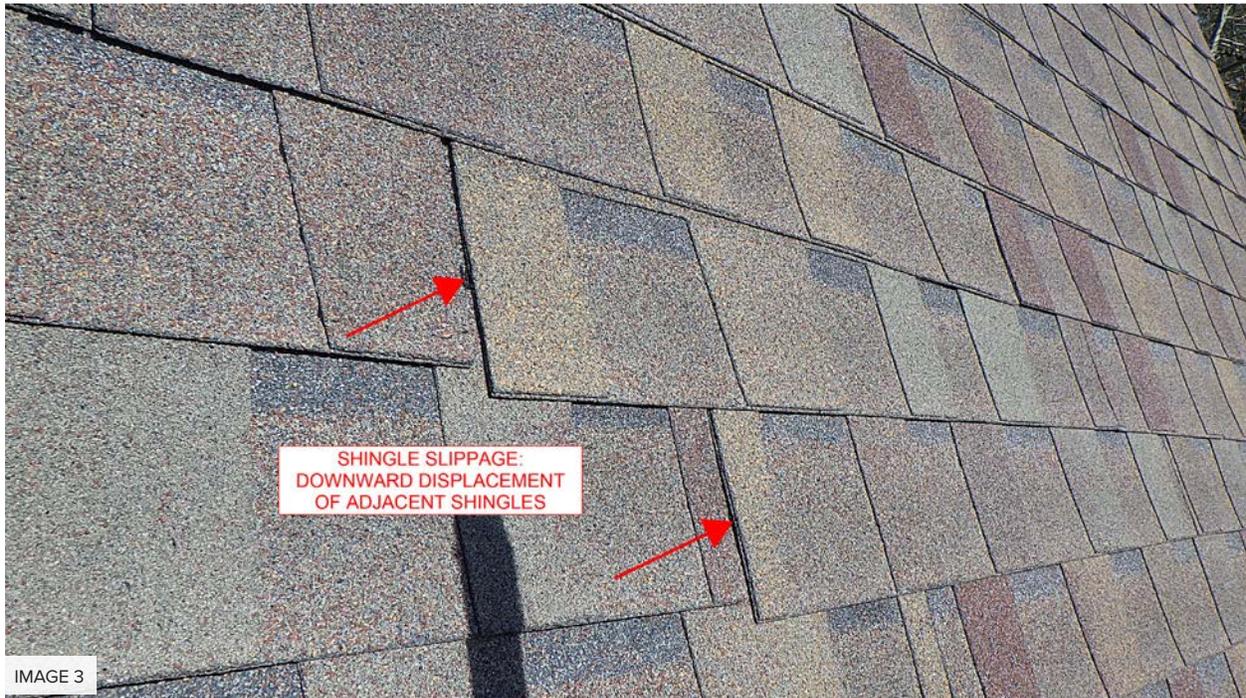
Now that we've reviewed some of the basics of laminated shingles and how they are attached to the roof deck, let's consider an issue we commonly observe on wind assessments (and commonly see misidentified as wind damage)—slipped shingles (see Image 3). Slipped shingles are those shingles displaced from their original position on the roof due to fasteners being improperly located and/or overdriven and thereby having a reduced or nonexistent attachment to the roof deck.

Shingle slippage commonly occurs in groupings of shingles that remain sealed to one another (Image 3). The displacement could be fractions of an inch, several inches, or the shingles could have slid into the gutter or fallen completely off the roof. A tear is commonly observed in the shingle immediately above the fastener, revealing how much the shingle has been displaced (see Image 4).

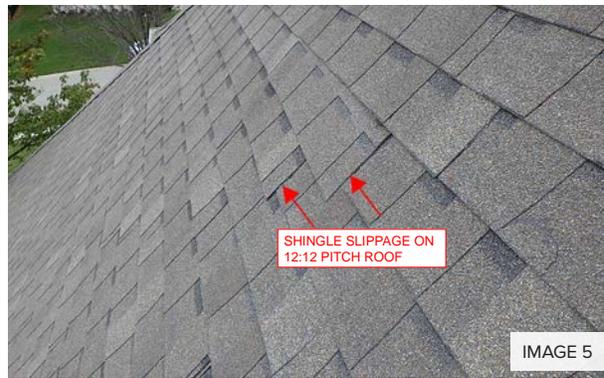
Shingle slippage commonly occurs on more steeply pitched roof slopes due to these shingles relying more heavily on the fasteners to hold them in place. As the roof pitch increases, the shingles bear less on the roof deck and “hang” more from the fasteners, and if these fasteners aren’t installed correctly, the shingles can become detached and displaced (Image 5).

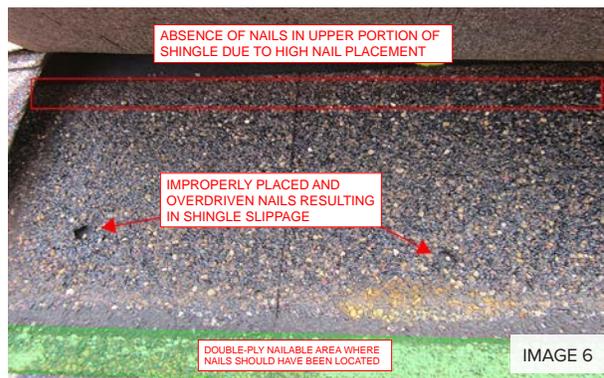
Four fasteners (for standard shingle installations) should be utilized; the fasteners should be properly located within the double-ply nailable area and a second row of four fasteners should penetrate near the top of the shingle (Image 6).

Overdriven fasteners result in the fastener head penetrating or cutting into the shingle surface and thereby reducing or completely eliminating the holding power of the fastener. This commonly occurs when improperly placed fasteners penetrate the single-ply upper laminate immediately above the double-ply nailable area, as a small gap, or air void, is present at the double-ply to single-ply transition, and the driven fastener can easily “punch through” the shingle (Images 6 and 7).
