## SOLVING THE RESTAURANT KITCHEN FIRE MYSTERY

### HOW A SEEMINGLY MINOR DETAIL CAUSED A MAJOR LOSS

Author: Russ Wilson, CFI, CFEI – Fire Investigator, American Structurepoint

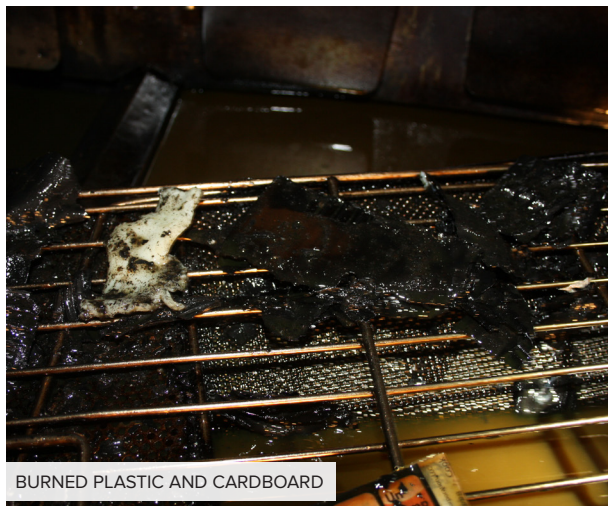
BURNED PLASTIC AND CARDBOARD

Russ then examined the fryer and could tell right away that the fire did not come from the mechanical system of the fryer. He also observed that the kitchen's fire suppression system did not work properly. The system is designed to dump an extinguishing agent onto the fryer that would extinguish the fire, but no agent could be found anywhere near the fryer. Next up, a little detective work. Russ picked up the fry baskets still sitting in the burned fryer and discovered a partially burned label, similar to a label on a cardboard box, covering a plastic vat of oil employees pour into the fryer. As Russ used a fry basket to fish through the oil in the fryer, he discovered small pieces of white plastic and pieces of burned cardboard floating in the oil.

He quickly sought out the manager and told him the employee was not telling the full story. The manager talked to the employee again, and the real story soon unfolded. With the fryer turned on, the employee saw that it was low on oil. He grabbed a box of fryer oil and propped it upside down atop the fryer so that the residual oil would drain out. He took a phone call in a nearby office, and when he next looked out, the container of oil and the cardboard box covering it had caught fire. That explained how the fire started, but why hadn't the fire suppression system discharged the agent to put out the fire?

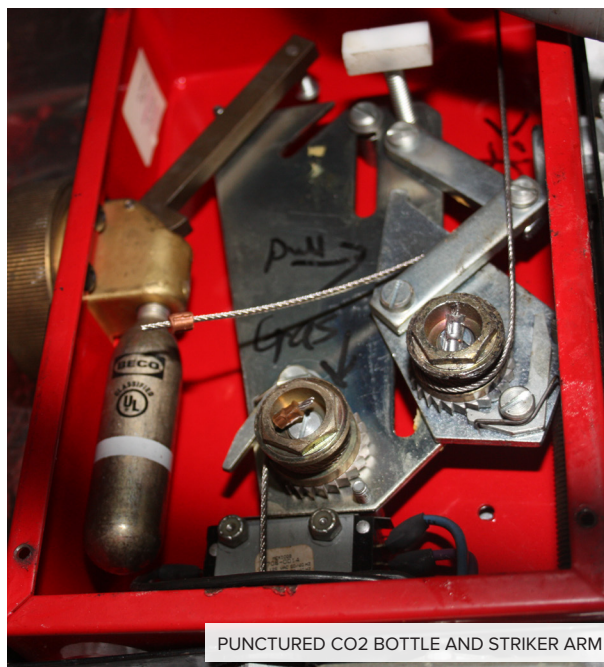
During the exam, they tested two cylinders of CO<sub>2</sub> to see if the striking pen would work as designed to expel the gas that would trip the extinguishing agent to flow through the suppression system. The system is designed to expel the gas quickly, but during the test, the release of CO<sub>2</sub> occurred slowly. Those attending the joint exam determined that another test was warranted; only this time, it should occur in a controlled environment at a lab. Russ had a construction crew specializing in moving heavy equipment disassemble the system, crate it, and move it to a lab about five miles south of the loss site.

PUNCTURED CO2 BOTTLE AND STRIKER ARM

Flash forward a few months to when the second joint exam occurred, complete with photography and video to document the process. In this exam, Russ thoroughly examined all components of the fire suppression system. The exam determined that three O-rings were at the top of the CO<sub>2</sub> cylinder instead of one O-ring according to installation standards. The extra O-rings created too much space so that when the striker arm released, just the tip of the needle punctured the CO<sub>2</sub> cylinder. This resulted in not enough pressure to open the bottle head to release the extinguishing agent.

Why were three O-rings inside the CO<sub>2</sub> cylinder? Russ learned that human error at the annual service was the culprit. When the technician, a trainee, serviced the CO<sub>2</sub> cylinder, he did not check to see if an O-ring was already inside the control head. The technician doubled what the installation standards called for and installed two new O-rings. The errant installation of two O-rings, which cost about 20 cents, ultimately led to a \$100,000+ fire loss.

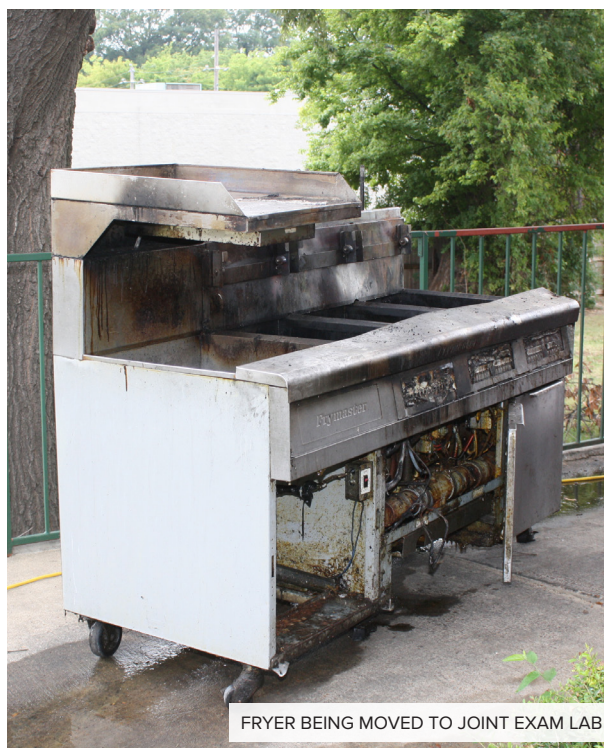
FRYER BEING MOVED TO JOINT EXAM LAB
