Structural Capabilities of No-Dig Manhole Rehabilitation

INFR1R12

Mohammad Najafi, Ph.D., P.E.

2015

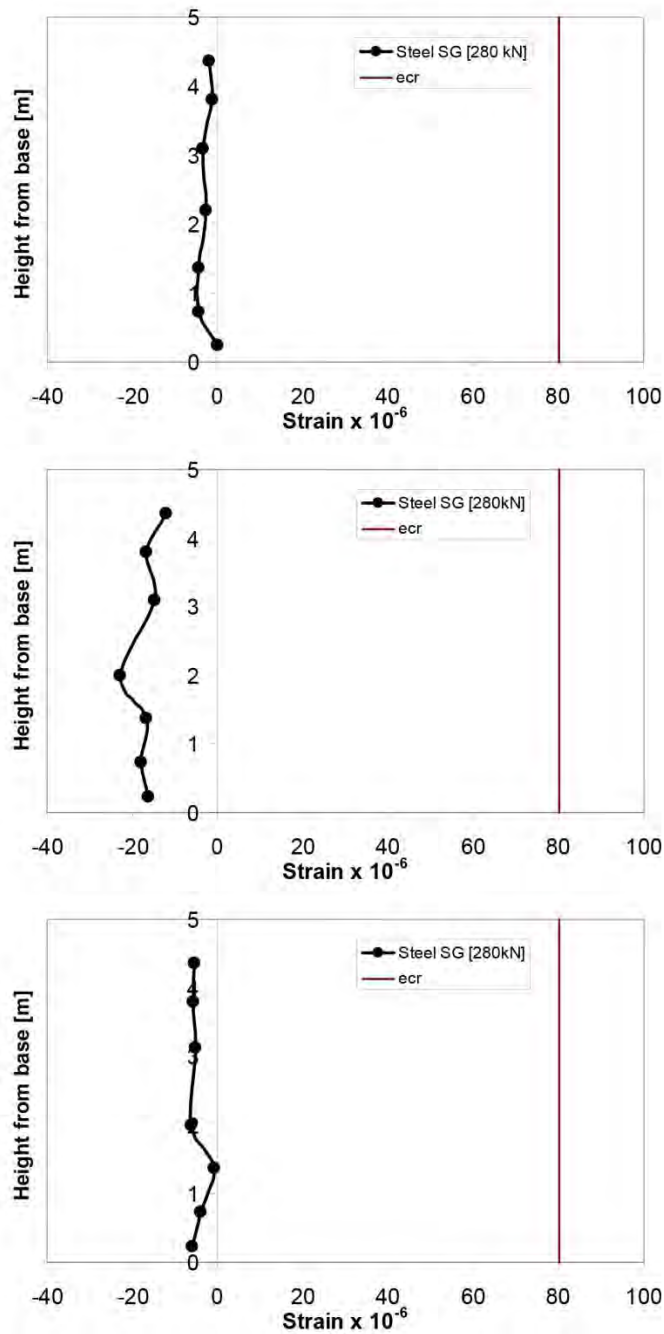
Figure 2-1. Axial Vertical Strain Profile in a Reinforced Manhole Wall Included in the Experiments for Three Different Load Patterns per the Canadian Highway and Bridge Code.

Sabouni's work is one of its kind, and to the research team's knowledge, is the only full-scale test applied on buried manholes with respect to their structural properties. The findings of the Sabouni study were used in designing and executing the tests and computational modeling conducted as a part of this research project.

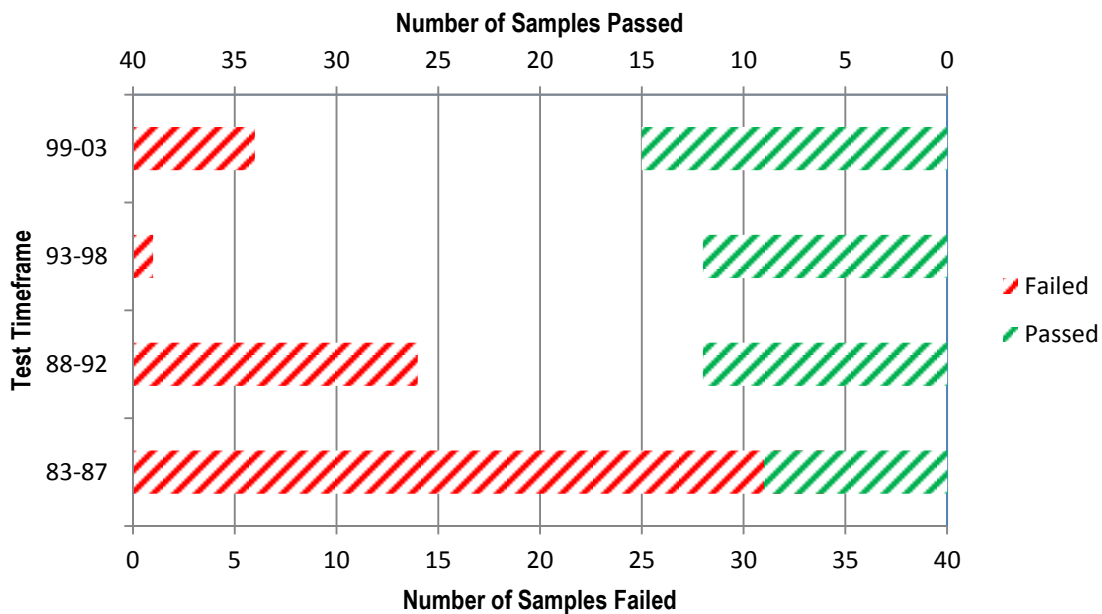
Figure 2-2. Pass/Fail Rate of the Tested Lining Materials over the 20-Year Testing Period.
Prepared from the Results of the Redner et al. Study.

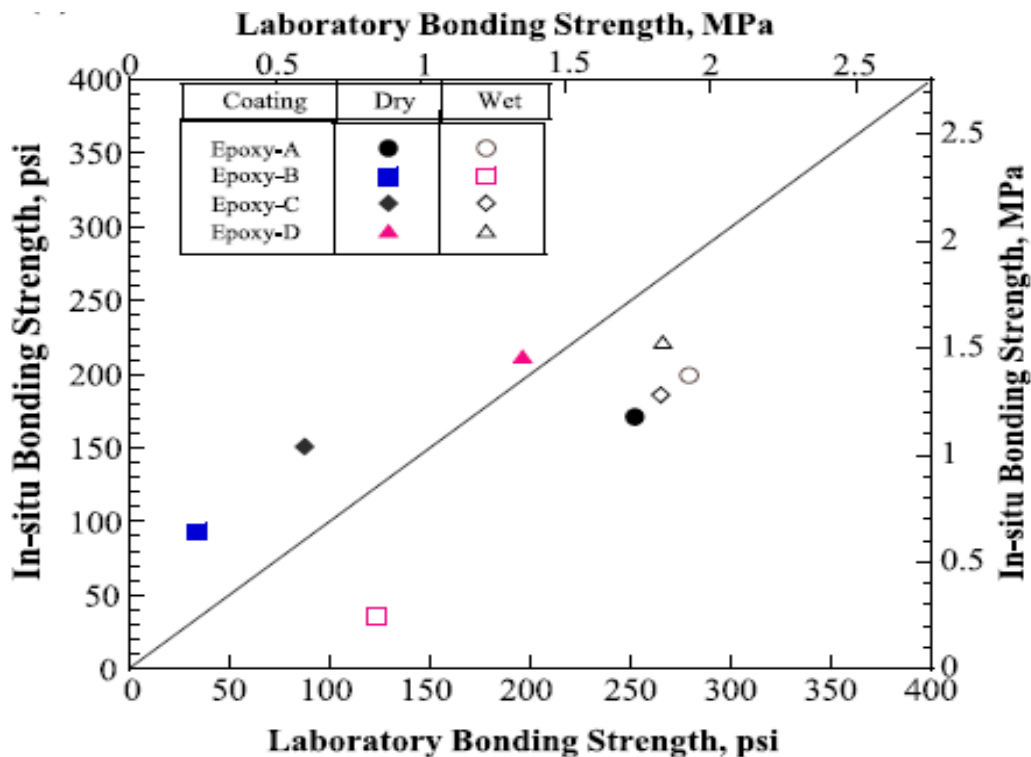
Figure 2-5. Comparison of Lab and In-Situ Bonding Strength (between epoxy coating and concrete) Test Results. Liu and Vipulanandan, 2004.

Liu and Vipulanandan used wet and dry substrates¹⁰ and applied the same experimental procedure in-situ on epoxy coated concrete pipe segments. They observed somewhat significant, but not substantial difference between results of the laboratory tests and that of in-situ.

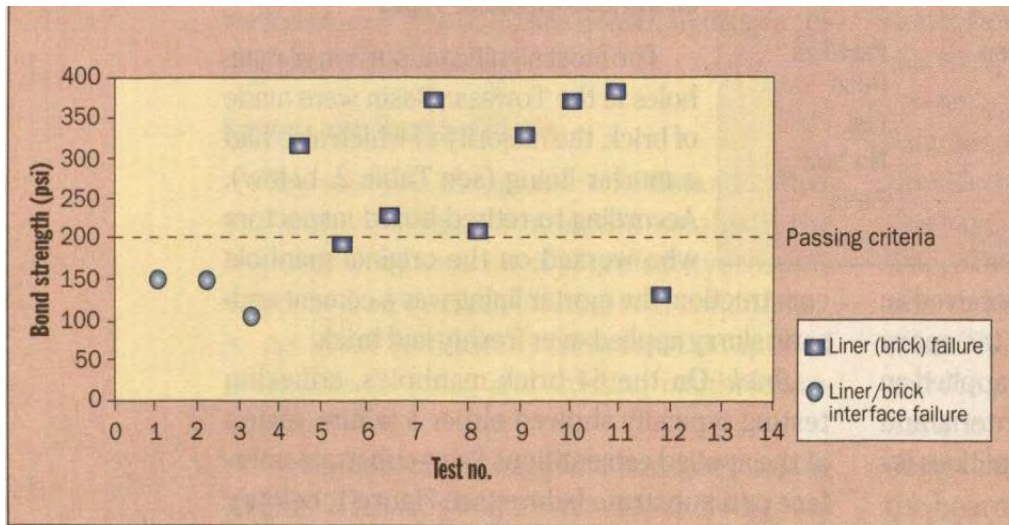
Figure 2-7. Results of Adhesion Testing of Cementitious Lining Over Brick.
Holmberg and Rowe, 1998.

Adhesion tests were applied on lined manholes using the American Concrete Institute Test Method 503 (ACI 503R, 1993 – reapproved 1998). The sewage basin included four types of manholes; i.e., brick, mortar lined brick, cast-in-place concrete, and precast concrete. The results of the adhesion tests varied remarkably depending on type of the substrate, i.e., cement mortar lining had better adherence on brick in comparison with cement mortar or concrete surface (see Figures 2-7 and 2-8).

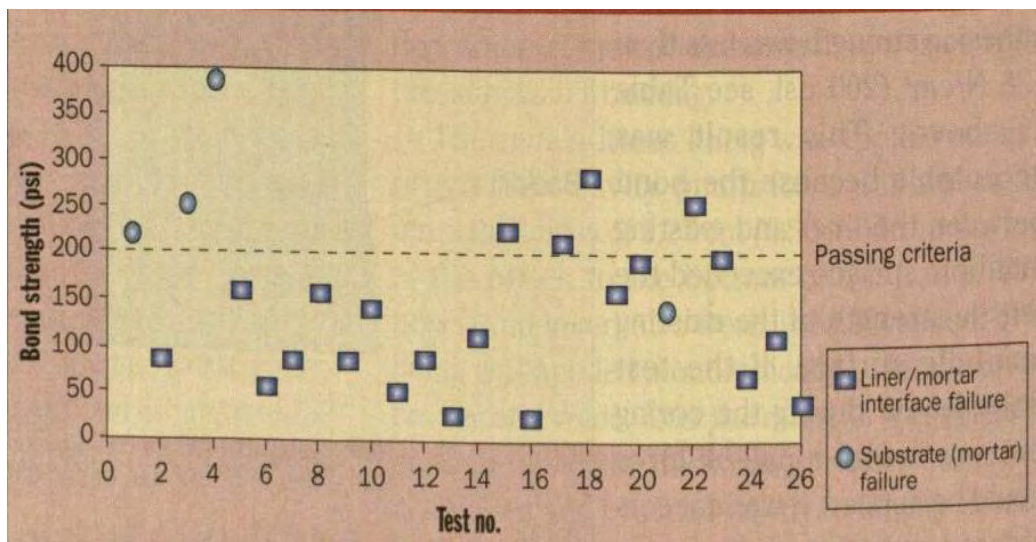
Figure 2-8. Results of Adhesion Testing of Cementitious Lining over Cement Mortar.
Holmberg and Rowe, 1998.

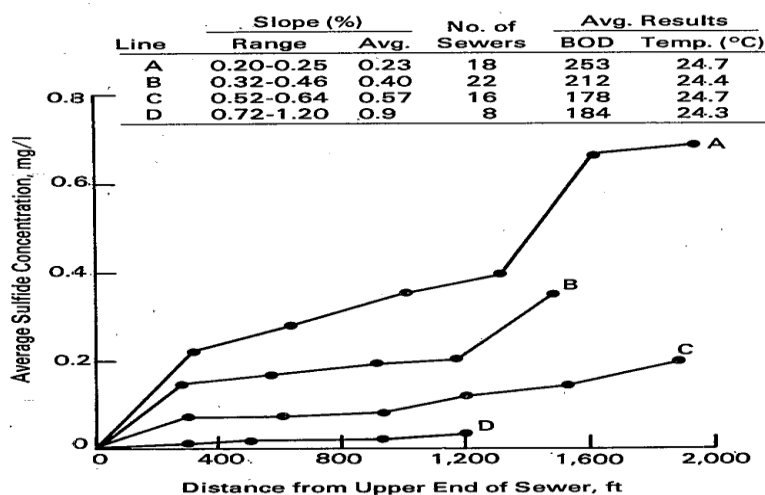
Figure 2-9. Sulfide Occurrence in Small Sewers.
U.S. EPA, 1985.

U.S. EPA released a design manual to prevent odor and corrosion control for sanitary sewers back in 1985 (*Odor and Corrosion Control in Sanitary Sewerage Systems and Treatment Plants/EPA/625/1-85 018*). The U.S. EPA manual emphasizes the effects of slope/velocity and temperature on sulfide generation in sanitary sewer systems (Figure 2-9).

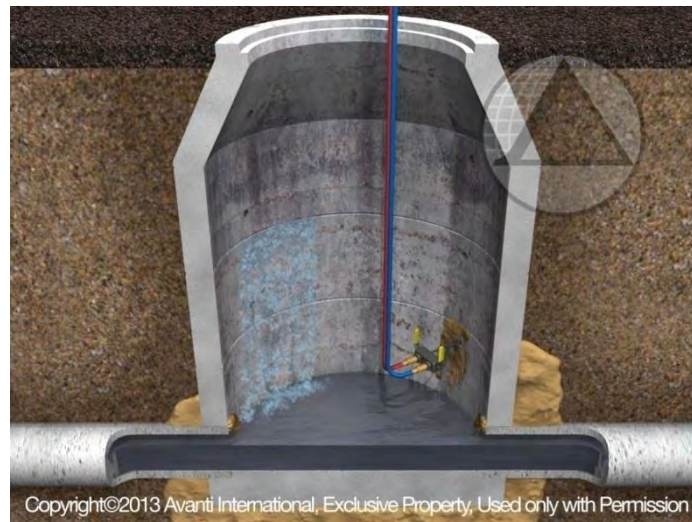
Figure 2-11. Chemical (Acrylamide) Grout Injection from the Inside of the Manhole to Stop Leaks.
Source: Avanti International.

- ◆ Chemical or Cement Mortar Grout: Chemical or cement mortar grout injection is another inexpensive method to seal leaks that enter into the manhole through cracks and joints. Grout sealants are suitable for structurally sound manholes or could be applied prior to lining a manhole to stop leaks. They can be applied directly on the crack/gap or injected through a hole drilled on the manhole wall from the inside (Figure 2-11). The latter method works by filling in the voids around the manhole, thereby sealing it externally.

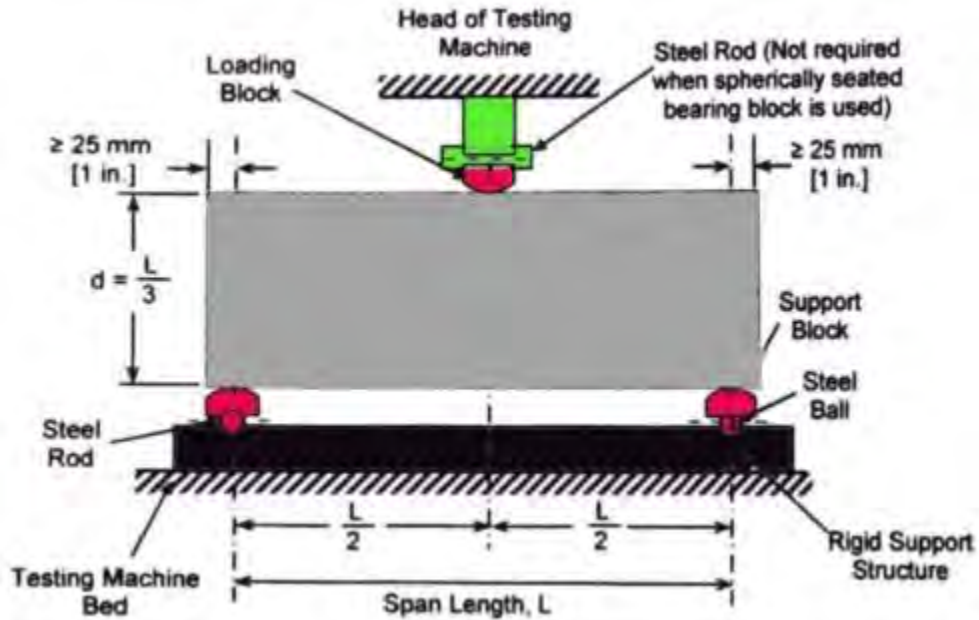
Figure 4-1. Flexural Strength Test Setup per ASTM C293.

Flexural strength of a solid is defined as its ability to withstand failure from bending. In concrete, it is generally measured by loading 6 in. × 6 in. × 20 in. (152 mm × 152 mm × 508 mm) concrete beams. Flexural tests are sensitive to specimen preparation, handling, and curing procedure. Standard specimens are heavy, and insufficient curing of specimen will yield lower strengths; therefore, in this experiment due to the need for sample shipment for lining purposes, a smaller specimen size, 3 in. × 3 in. × 8 in. (76 mm × 76 mm × 203 mm) was used. The 3 in. × 8 in. (76 mm × 203 mm) bottom surface was lined with a manhole rehabilitation material to compare the flexural behavior of lined concrete with that of the control specimen (unlined concrete beam).

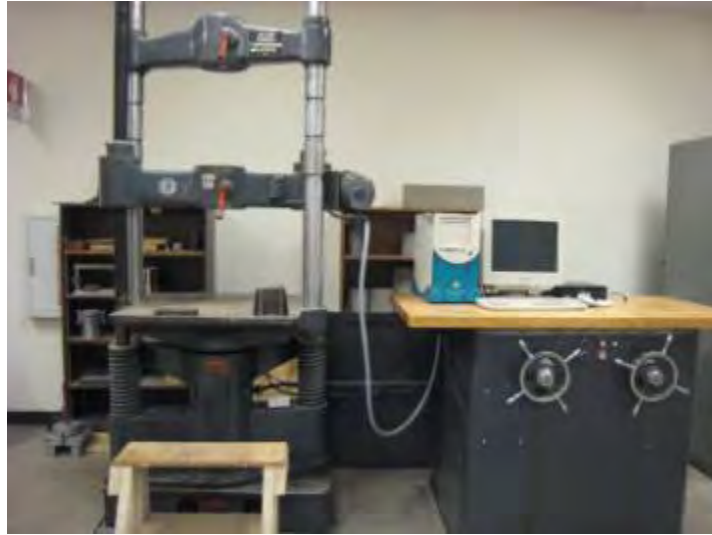
Figure 4-2. Baldwin 60 KIP Flexural Strength Testing Machine.

Two of the widely used standards for testing concrete beams for flexural strength are: ASTM C78 and ASTM C293. In ASTM C78 a simple concrete beam is tested by third-point loading. In ASTM C293 a simple concrete beam is tested by center-point loading (Figure 4-1). ASTM C293 is followed for the preliminary experiments. The results of this test method may be used to determine compliance with specifications or as a basis for proportioning, mixing and placement operations. This test method produces values of flexural strength significantly higher than Test Method C78. The flexural strength found is expressed as the MR in MPa or psi. A 60 KIP Baldwin flexure testing machine (see Figure 4-2) was used for the flexural strength tests.

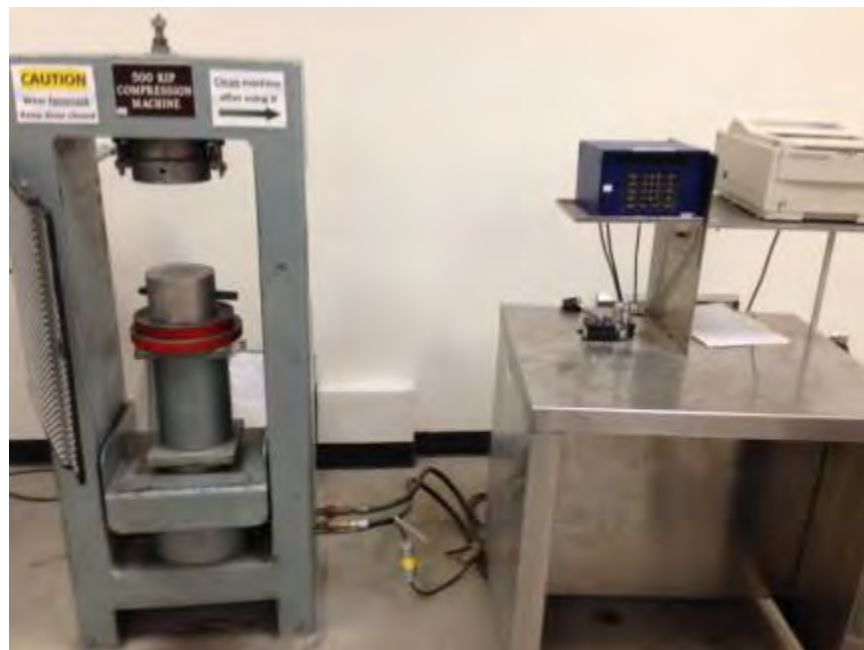
Figure 4-3. The Testing Instrument (ADMET 500 KIP) Used for the Compressive Strength Tests.

The small cube test specimens (ASTM C109) were easy to prepare and ship to the lab from various parts of the country, where the substrates are to be lined by the manufacturers for testing. Nevertheless, some of the lining materials included in this study cannot be applied on the standard small cube substrate; and the project team was intended to keep the substrate identical for all of the lining materials included in this study to compare the results; so that they could be classified with respect to their structural capabilities. The concrete cylinder substrates were lined externally by the manufacturers; and shipped to CUIRE for a compressive strength test that is parallel to ASTM C39.

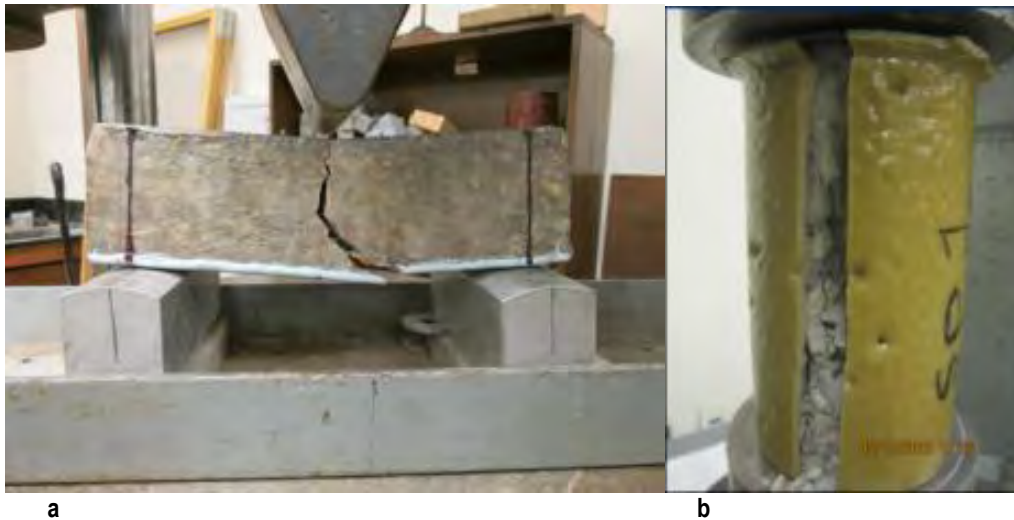
Figure 4-13. Beam (a) and Cylindrical (b) Specimens at Failure While Loaded for Flexural and Compressive Strength, Respectively.

The project team tested one epoxy spray applied lining materials (EPX1)¹³ one cured-in-place applied lining material (CIP), one polyurea spray applied lining material (PU), one cement-polymer composite (CMP), and one multi-layer polymer composite (MULT) for flexural strength and compressive strength. Five identical beam and cylinder specimens were lined by the manufacturer using their standard procedure (including surface prep) and tested at CUIRE by three-point bending and compressive loading until failure (Figure 4-13).

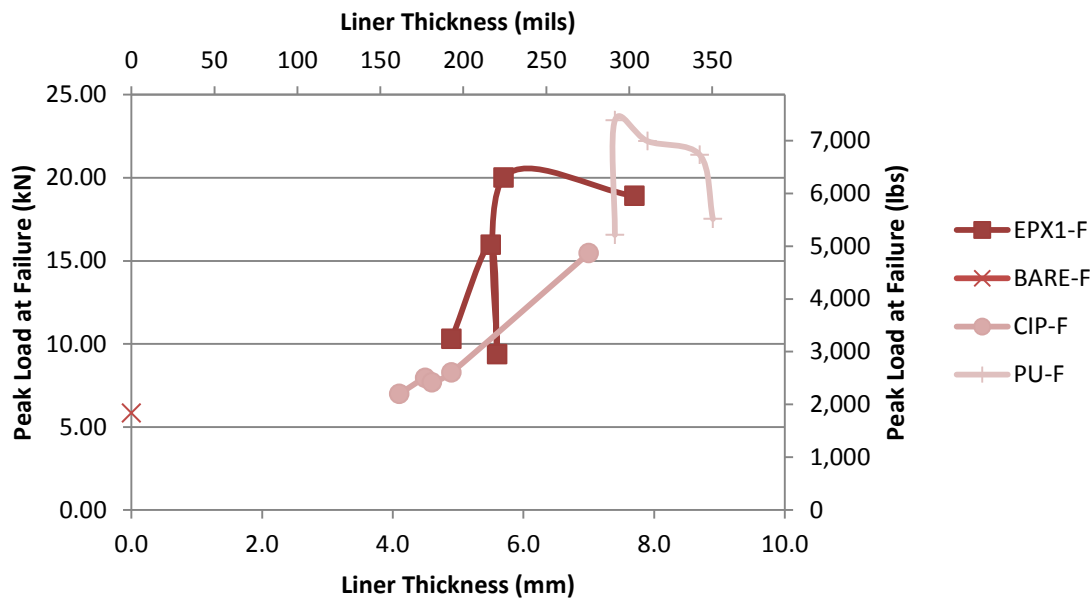
Figure 4-16. Peak Load at Failure (Ultimate Flexural Strength) vs. Liner Thickness Based on the Preliminary Tests.

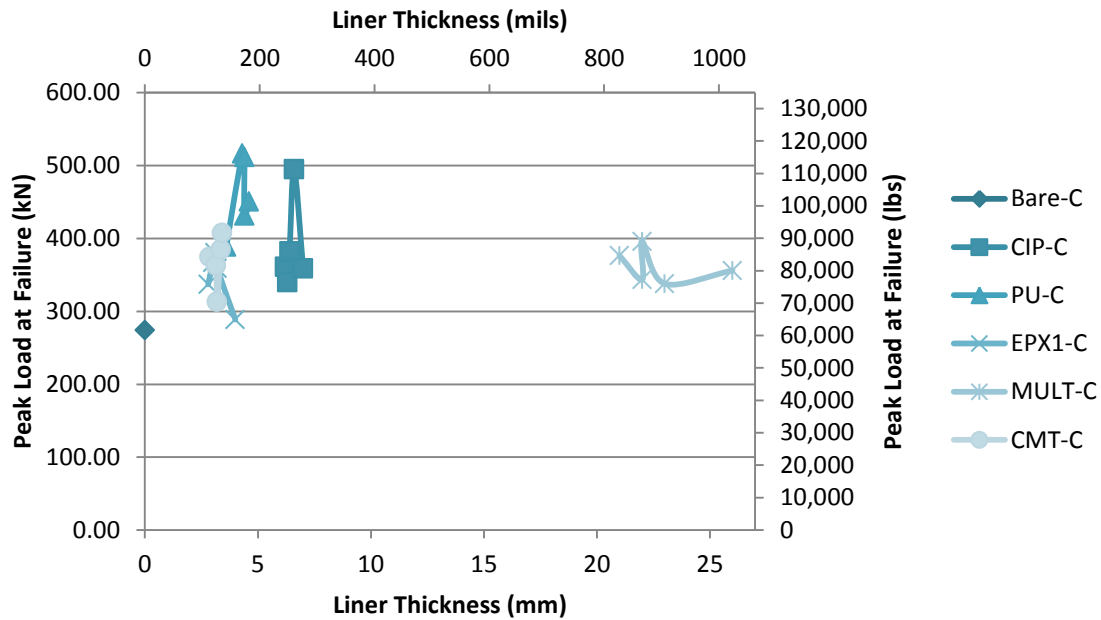
Figure 4-17. Peak Load at Failure (Ultimate Compressive Strength) vs. Liner Thickness Based on the Preliminary Tests.

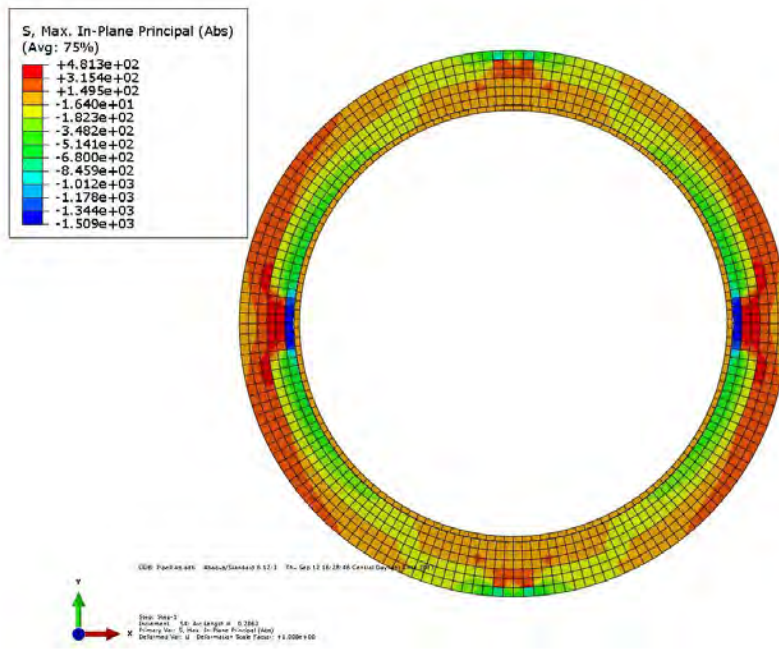
Figure 4-20. Stress Contours from the FEM Based on the D-Load (ASTM C497) Test on High-Build Epoxy Lined 24-in. (610 mm) Reinforced Concrete Cylinder.

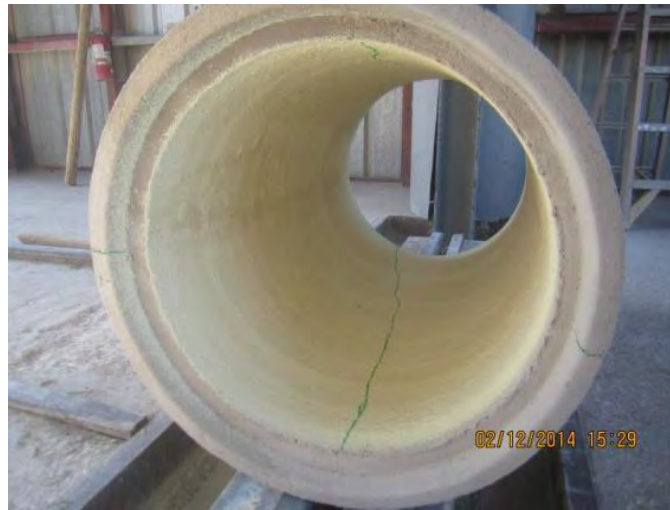
Figure 4-21. Example of Simultaneous Cracking in the Concrete Substrate and Liner.

Table 4-12 shows a summary of the main test results. All of the lining materials significantly (or substantially for some) improved the crushing strength of the 24-in. concrete pipe. The main test results suggest that even spray applied epoxies and cast-in-place cement linings can substantially enhance the structural properties of a reinforced concrete cylinder if they are applied firmly at a certain thickness. On the other hand, some of the liners (e.g., MULT, PU) survived the crushing test without an apparent failure when the concrete substrate failed by tensile stress cracking at 3:00 and 9:00 o'clock positions. This is essentially due to lower adhesion and/or high flexibility, and does not necessarily translate to higher peak loads at failure. Figures 4-21 and 4-22 indicate examples of liner failures due to cracking and concrete substrate failure at the peak load while the lining remained intact.

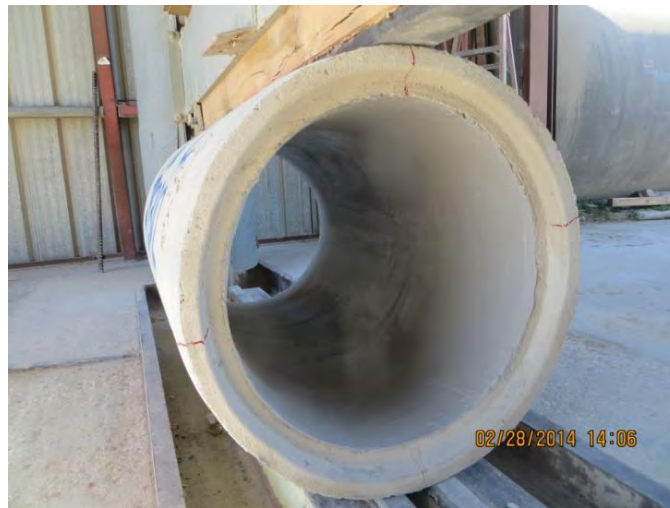
Figure 4-22. Example of Failure by Cracking in the Concrete Substrate Only.

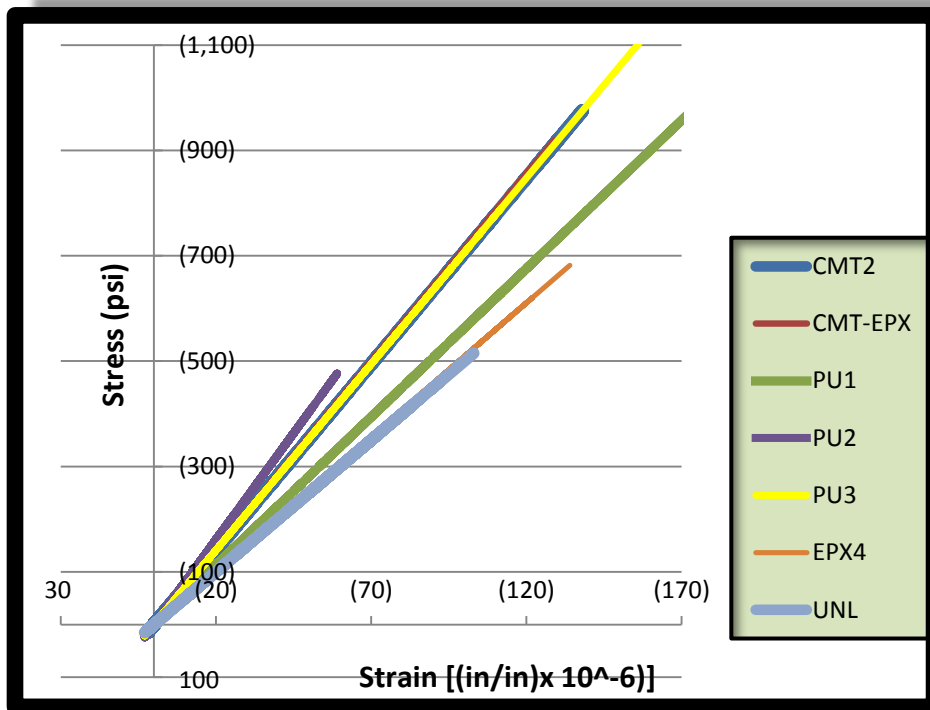
Figure 4-23. Stress vs. Compressive Strain Graph for the Unlined and Lined Samples.

Another way of examining the added strength by the lining materials to the sample pipes is looking at the modulus of elasticity of the lined system, which is the slope of stress vs. strain plot for the elastic region. This was approximated by calculating the overall stiffness and modulus of elasticity of the lined samples on which strains were measured during loading and material properties of each component of the lining system were known. Then these moduli of elasticity values were multiplied by the strains to achieve stresses in tension and compression (depending on where the strain gage is positioned). Stress vs. strain graphs for the tension and compression zones are shown in Figures 4-23 and 4-24. The results shown in these graphs suggest a significant increase in the lined system modulus of elasticity for both in tension and compression. This significant increase in the modulus of elasticity applies to all of the lined specimens except one epoxy lined specimen (EPX-4).

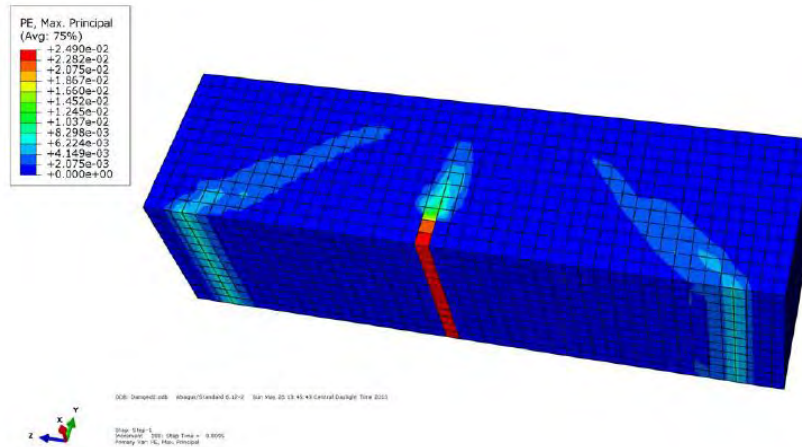
Figure 5-2. Plastic Strain in the Concrete Beam.

The load vs. the deflection data from the experiments were applied to the Abaqus model in pursuit of the best match between simulation and laboratory tests. When the best match was obtained (minimum 85%), the parameters used for the concrete damage model were the calibrated parameters and considered as the true parameters for manhole simulation. Figure 5-2 shows the contours of the plastic strain of the concrete beam under 3,000 lbs. (13.3 kN) of load. It clearly demonstrates that the center bottom develops the largest plastic strain. This is not surprising as this is where failure occurred on the beam specimens (discussed in Chapter 4.0).

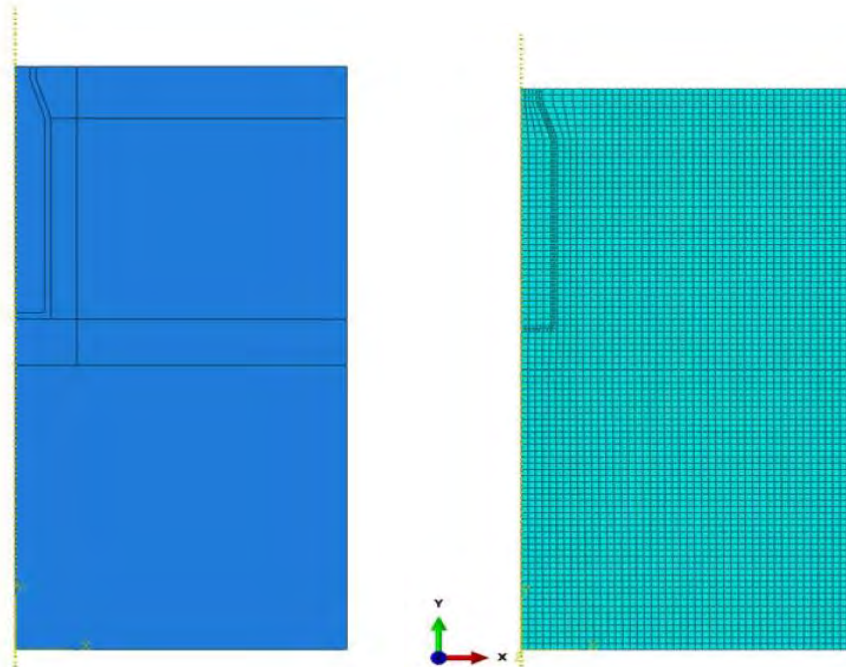
Figure 5-6. Geometry of the Manhole Model.

For the manhole structure and the lining, a four-node bilinear axisymmetric quadrilateral, reduced integration, hourglass control (CAX4R) was used and the soil was modeled by using a four-node axisymmetric quadrilateral, bilinear displacement, bilinear pore pressure (CAX4P).

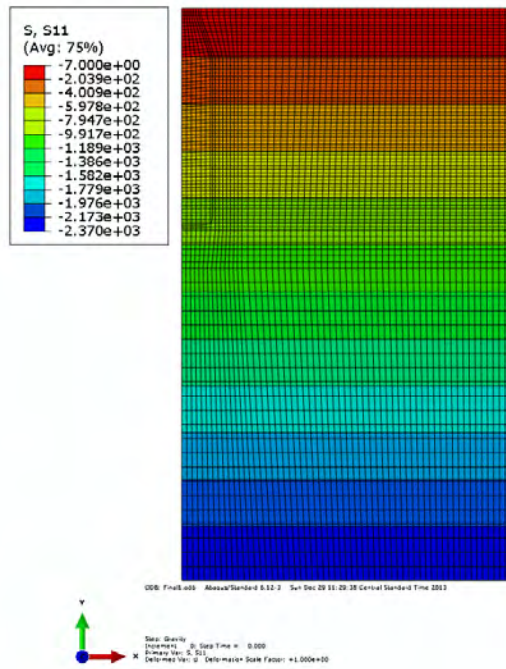
Figure 5-7. Geostatic Stress in Soil Mass.

For soil modeling in Abaqus the first step is obtaining geostatic stress in the soil. In this simulation the geostatic stress was obtained by considering the whole simulation domain as soil mass only in the initial step. The vertical soil stress was applied as predefined field data, which was calculated by multiplying unit weight of the soil to the height of the soil mass. In the first step the gravity load was applied and geostatic stress was obtained through geostatic analyses. As shown in Figure 5-7, at the end of the first step, the stress distribution was achieved according to the unit weight of the soil without observing any considerable deformation in the soil.

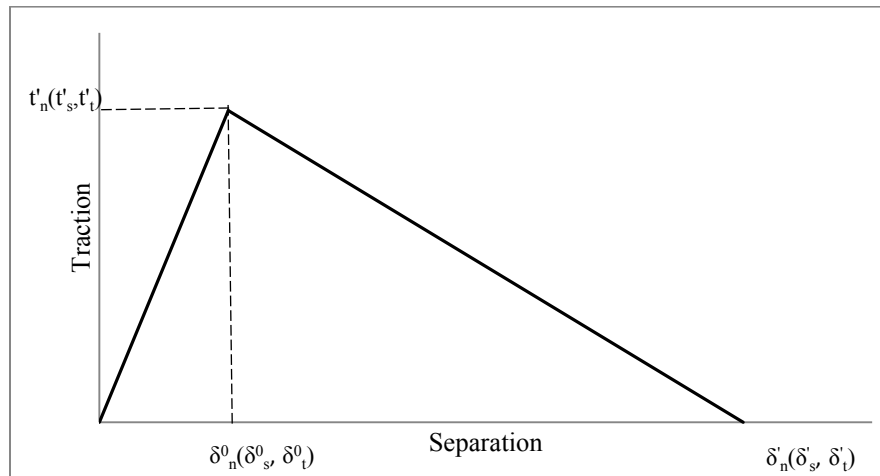
Figure 5-8. Typical Traction Separation Response.

Damage modeling allows one to simulate the degradation and eventual failure of the bond between two cohesive surfaces. The failure mechanism consists of two components: a damage initiation criterion and a damage evolution law. The initial response is assumed to be linear as discussed above. However, once a damage initiation criterion is met, damage can occur according to a user-defined damage evolution law. Figure 5-8 shows a typical traction-separation response with a failure mechanism.

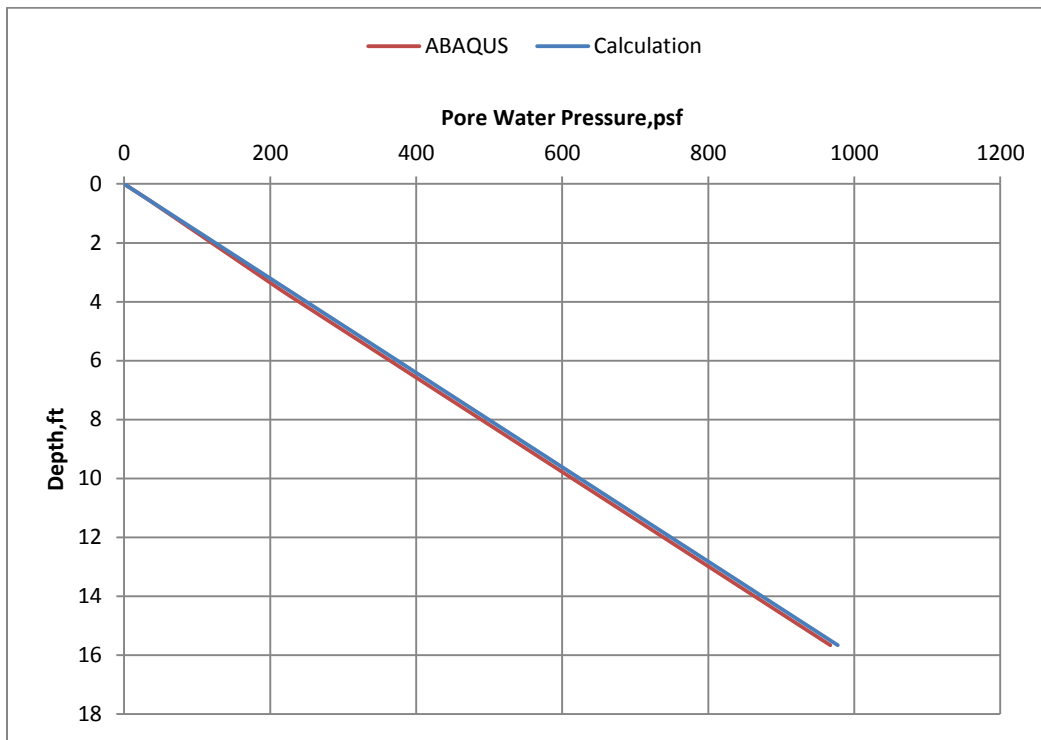
Figure 5-10. Pore Water Pressure vs. Depth.

The other lateral pressure acting on manhole structure during operation was groundwater pressure. The simulation of the water pressure was conducted by assigning permeability and void ratio of the soil as 1.0 ft/day (0.3 m/d) and 0.6 respectively in material property of the soil. The void ratio of the soil was also assigned as predefined field parameter as a constant value of 0.6 to the soil mass in the initial step. Pore water pressure was assigned by using a boundary condition of pore pressure type, equal to zero at the surface of the ground in the initial step. By assigning this boundary condition the program considers a linear distribution of water pressure in depth. After achieving geostatic stress in the first step the second step was defined as “soil” procedure with transient consolidation state in order to consider presence of water in the porous material. Distribution of water pressure acting on manhole structure obtained from the FEM simulation and manual calculation are shown in Figure 5-10.

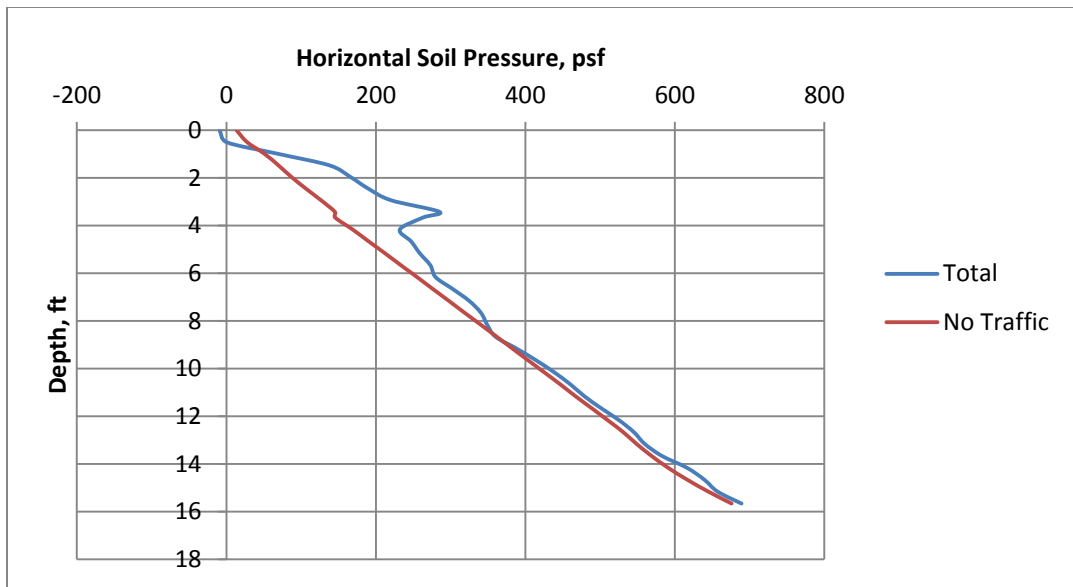
Figure 5-16. Comparison of the Lateral Load Acting on the Manhole Structure Due to Different Loading Cases.

The lateral pressure acting on the manhole structure considering two different loading cases are shown in Figure 5-16. One case refers to the condition in which soil pressure, pore water pressure and traffic load are applied and the other one is obtained from the situation without applying the traffic load. As shown in Figure 5-16, presence of traffic load has more effect for depths up to 3.5 ft. (1.1 m), which is the approximate depth of a cone (without a chimney) on top of the manhole wall. The lateral pressure illustrated in this figure refers to the active soil pressure condition (K_a).

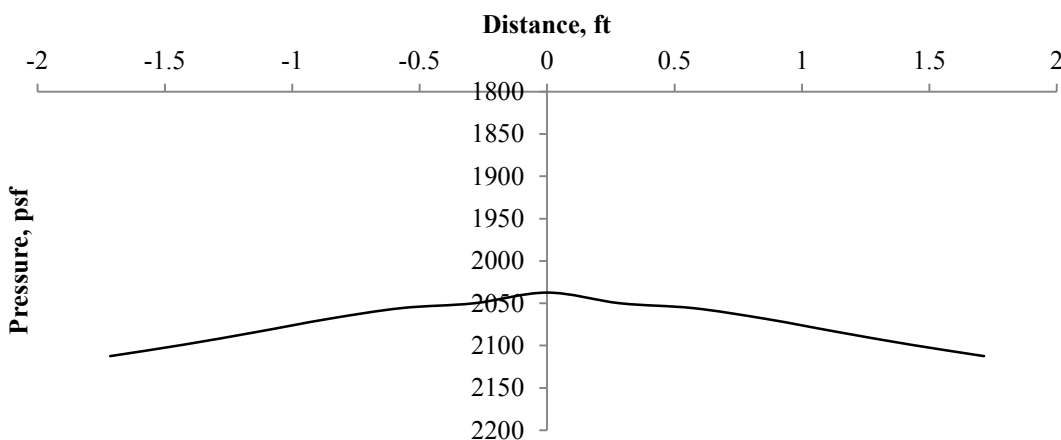
Figure 5-17. Soil Pressure Under Manhole Base.

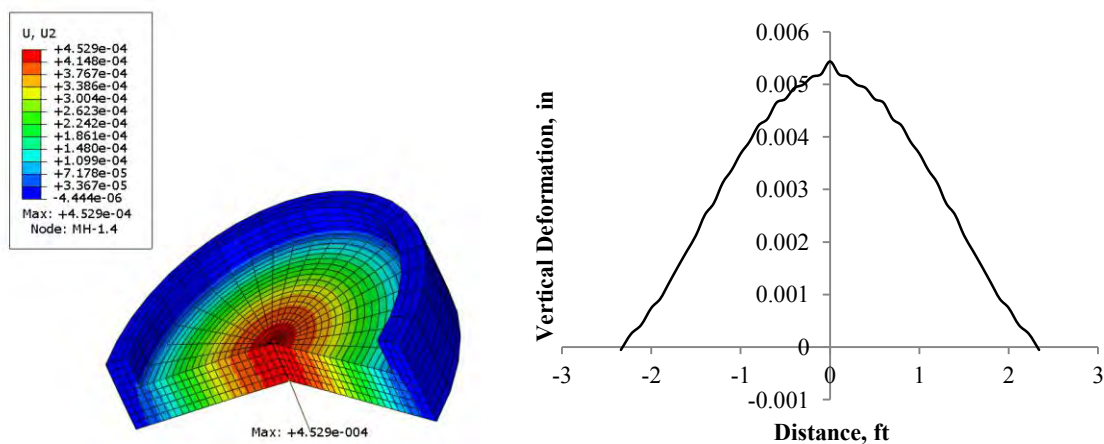
Figure 5-20. Vertical Deformation at the Base.

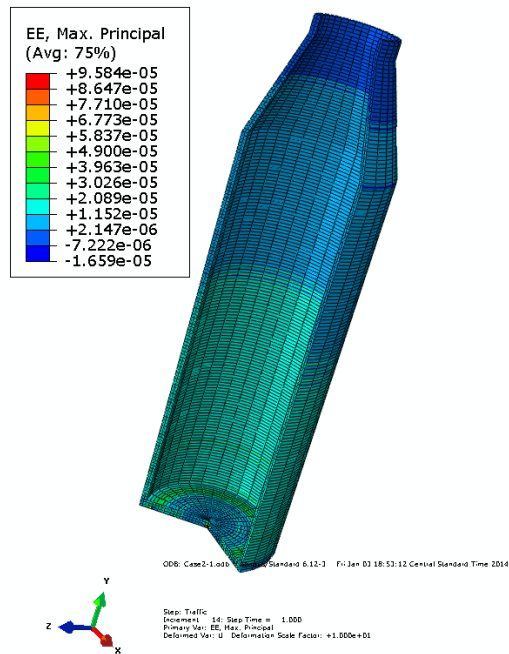
Figure 5-23. Maximum Principal Elastic Strain in Manhole Structure (C2-1).

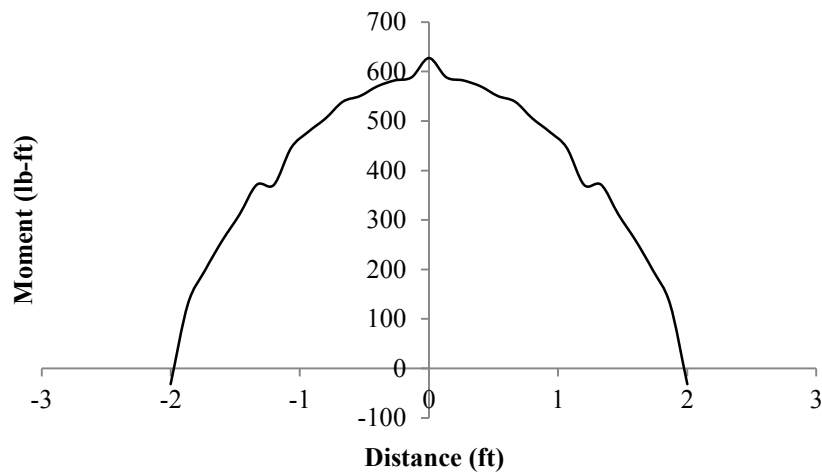
Figure 5-24. Moment Distribution in the Manhole Base (C2-1).

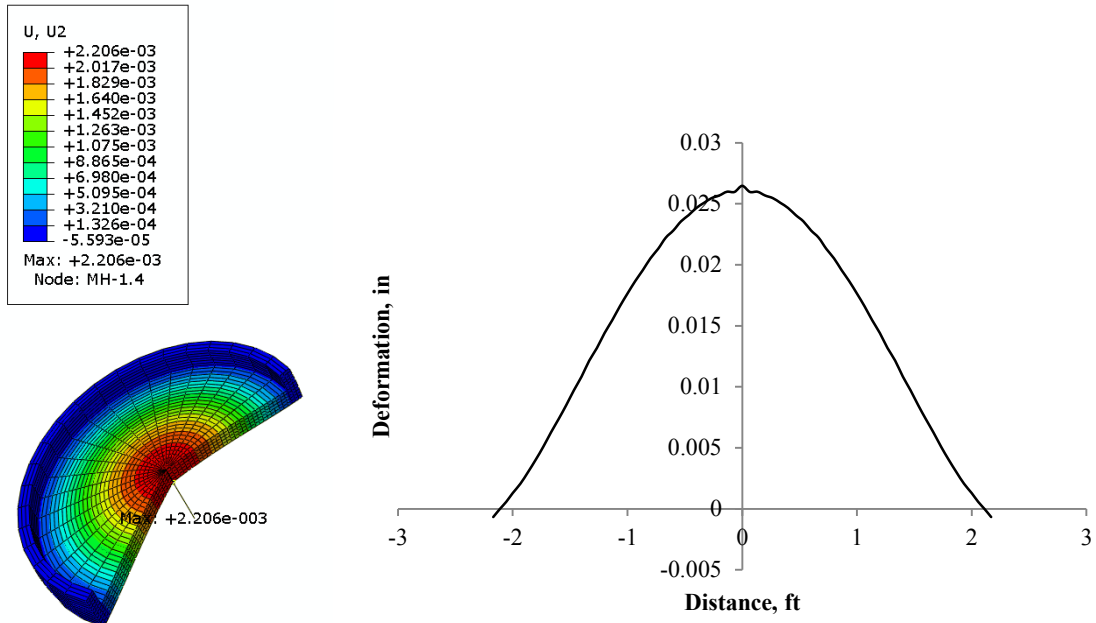
Figure 5-25. Vertical Deformation of the Manhole Base (C2-1).

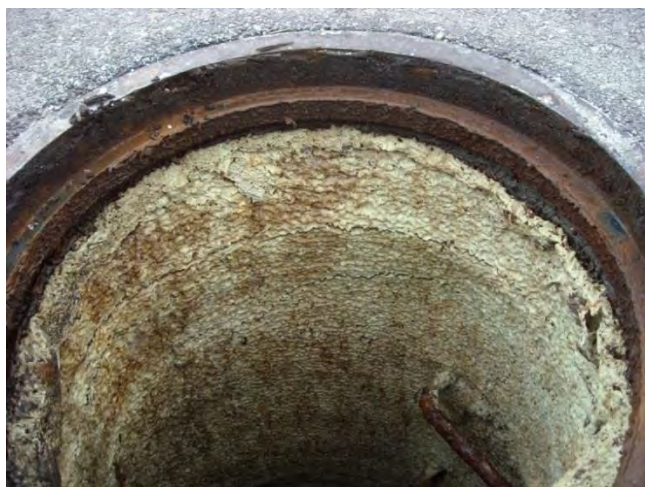
Figure 6-1. Blistering and Pitting Observed on a Composite Lining System.
(Cement Lining and Polymer Coating on Top)

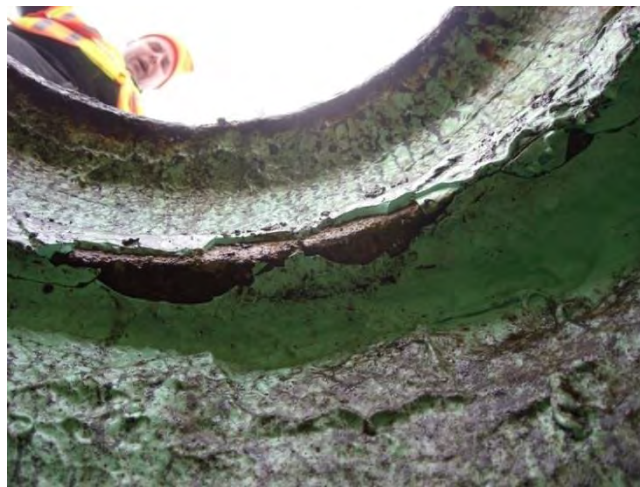
Figure 6-2. Polymeric Liner Failure Along the Edges Inside the Manhole.

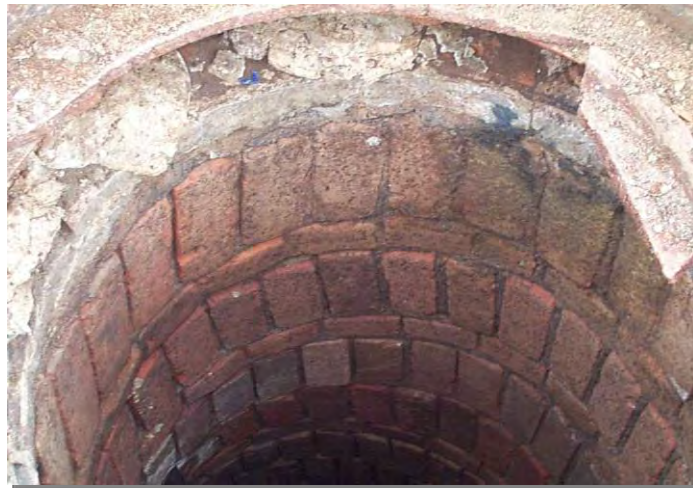
Figure 6-3. Corbel Condition Deteriorated.

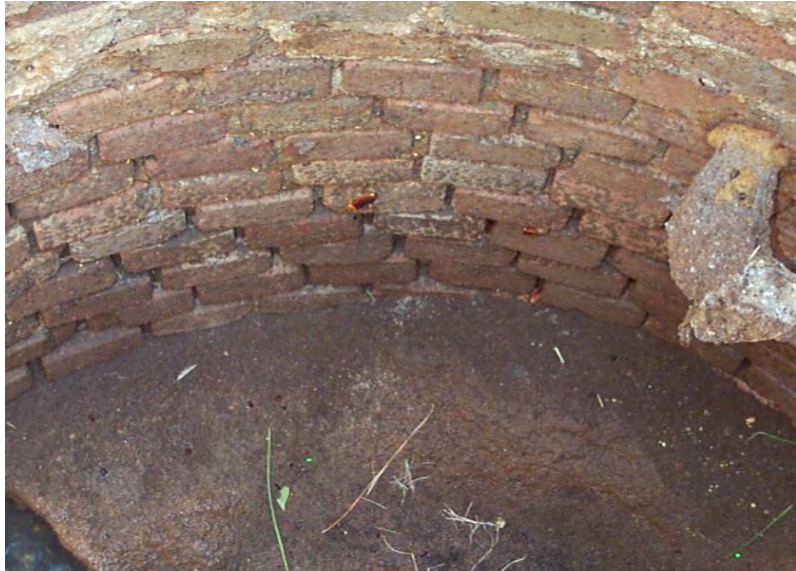
Figure 6-4. Wall Condition Deteriorated (Heavy).

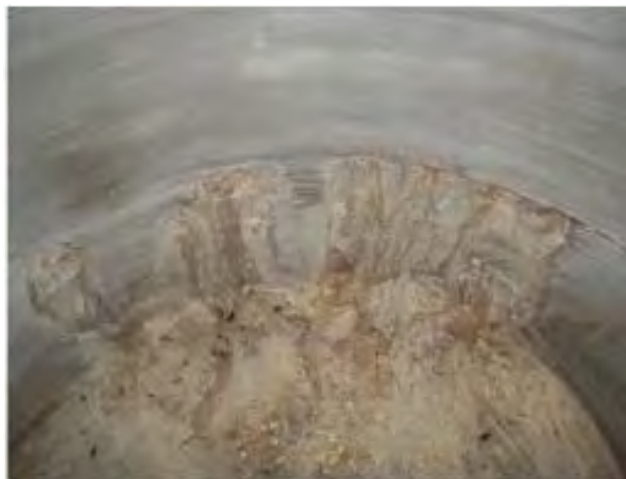
Figure 6-6. Cementitious Liner that Experienced Material Sloughing.

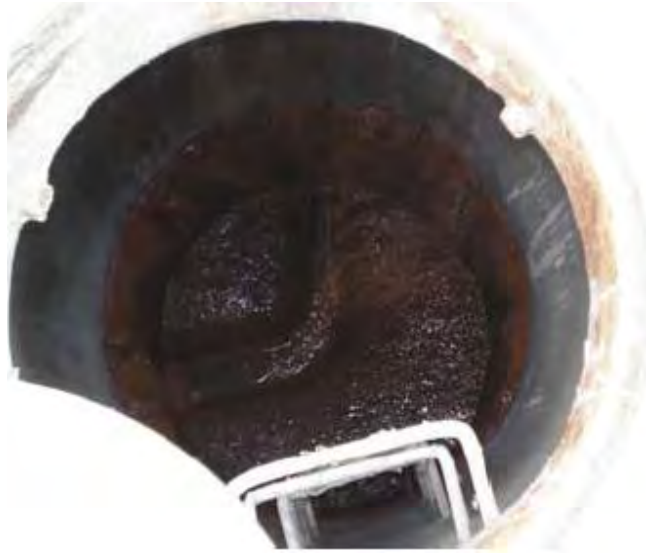
Figure 6-9. Infiltration (Runner) Along the Joints.

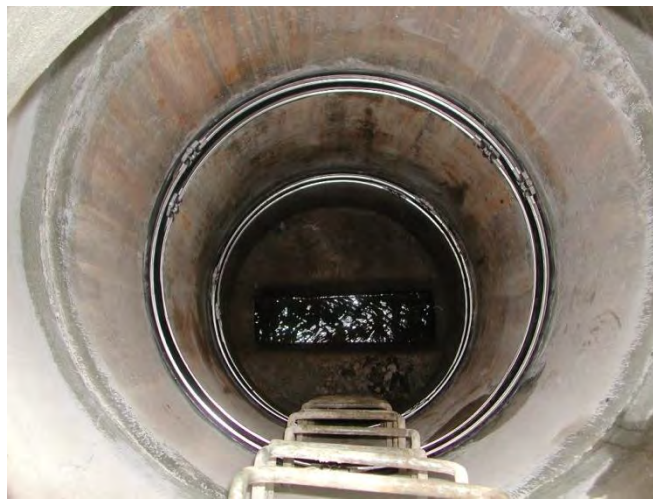
Figure 6-15. Example Manhole with Joints Internally Sealed to Prevent Infiltration.

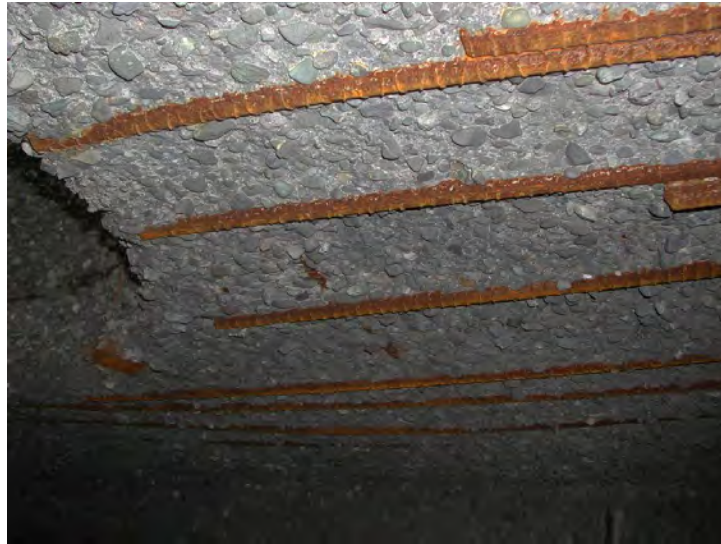
Figure 6-16. Junction Chamber Prior to Rehabilitation.
Note the Severe H₂S Induced Corrosion.

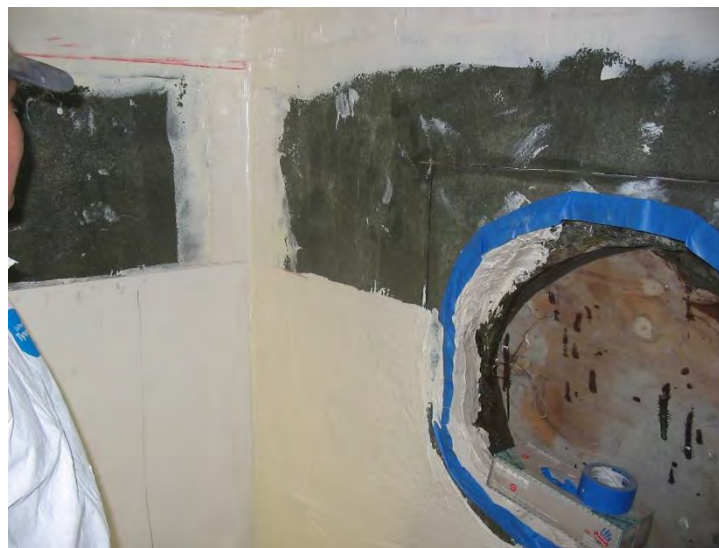
Figure 6-17. Two-Part (Extruded PVC Plus Cured-in-Place Polymer) Being Applied at the Junction Chamber.

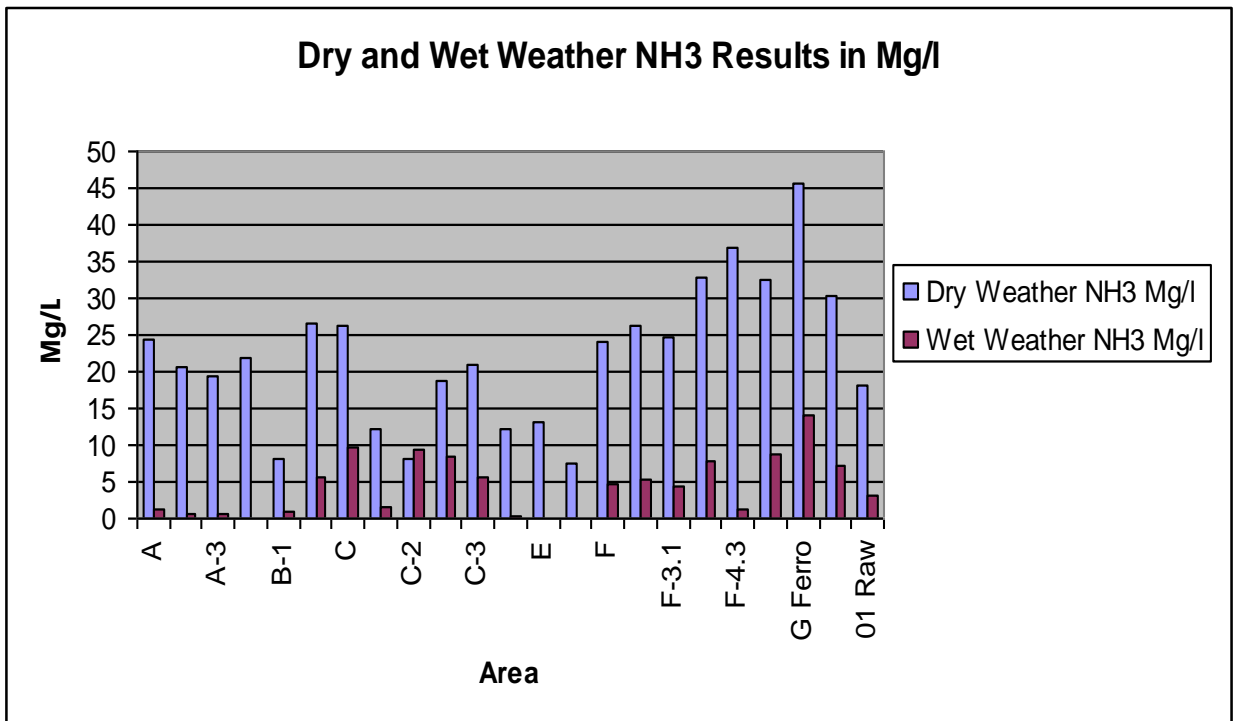
Figure 6-21. Comparison of Dry vs. Wet Weather Ammonia Concentrations in Sewage.
