Structural Capabilities of No-Dig Manhole Rehabilitation

INFR1R12

Mohammad Najafi, Ph.D., P.E.

2015

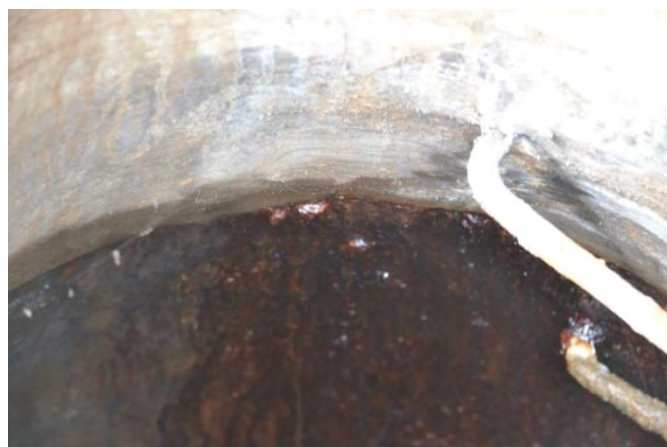
Figure 6-23. Infiltration/Inflow Marks Due to Cracking in the Fiber-Reinforced Cement Liner Within a Few Years of Installation.

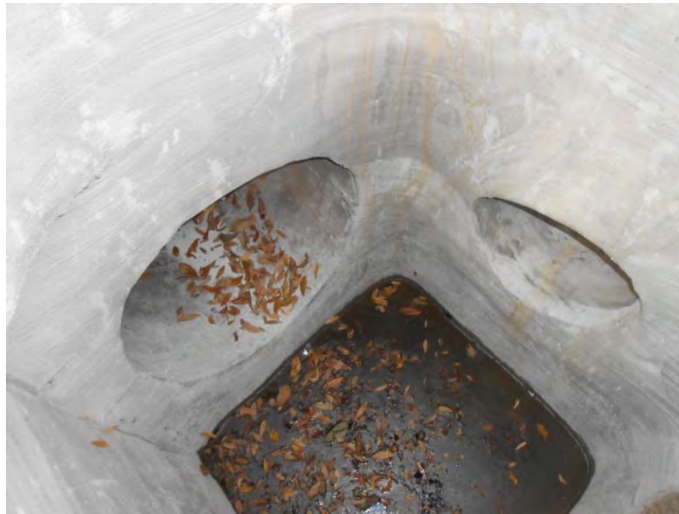
Figure 6-24. Manhole Lined with Calcium Aluminate Cement Liner.

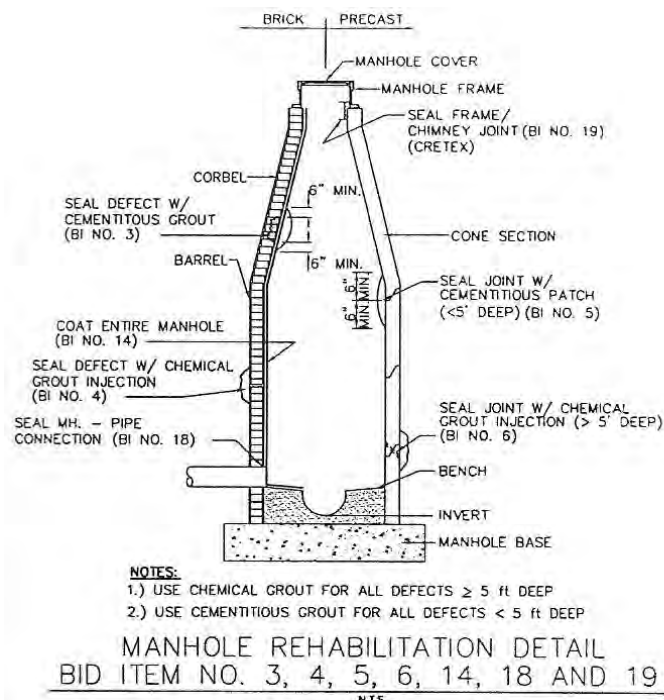
Figure 6-25. Manhole Rehabilitation Detail.

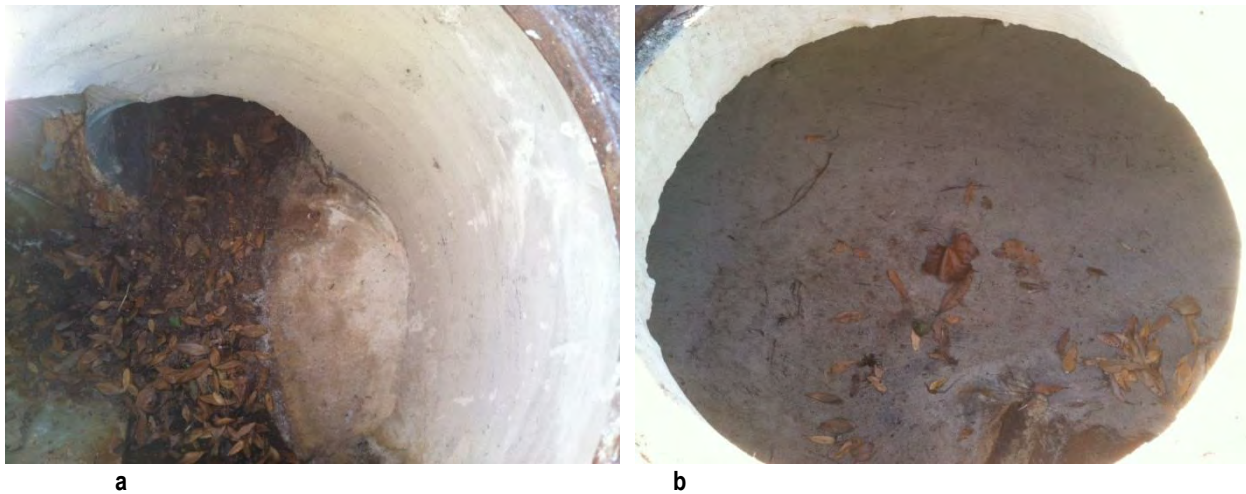
Figure 6-26. Manhole with Epoxy Shortly After Application (a) and After One Year of Service (b).

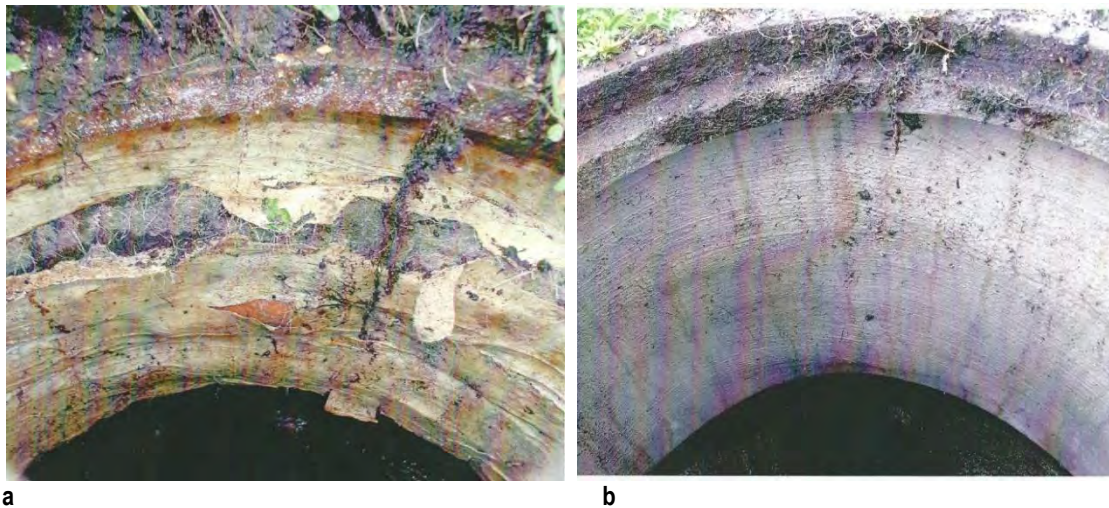
Figure 6-27. Manhole Needing Repair with a Failed Liner on (a) and the Same Manhole One Year After Rehabilitation with Calcium Aluminate Cement (b).

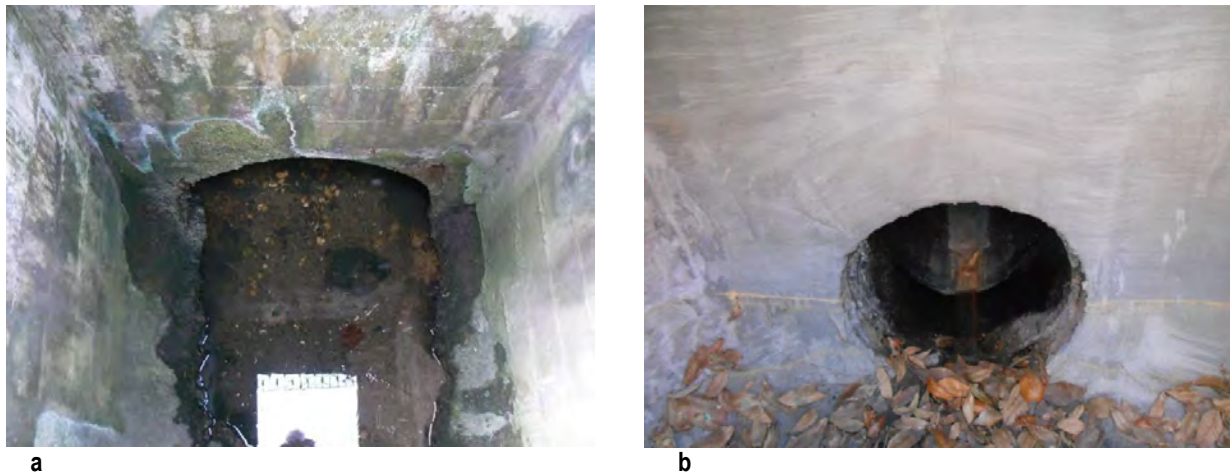
Figure 6-28. Catch Basin Before (a) and After (b) Rehabilitation with Cement Mortar Liner.

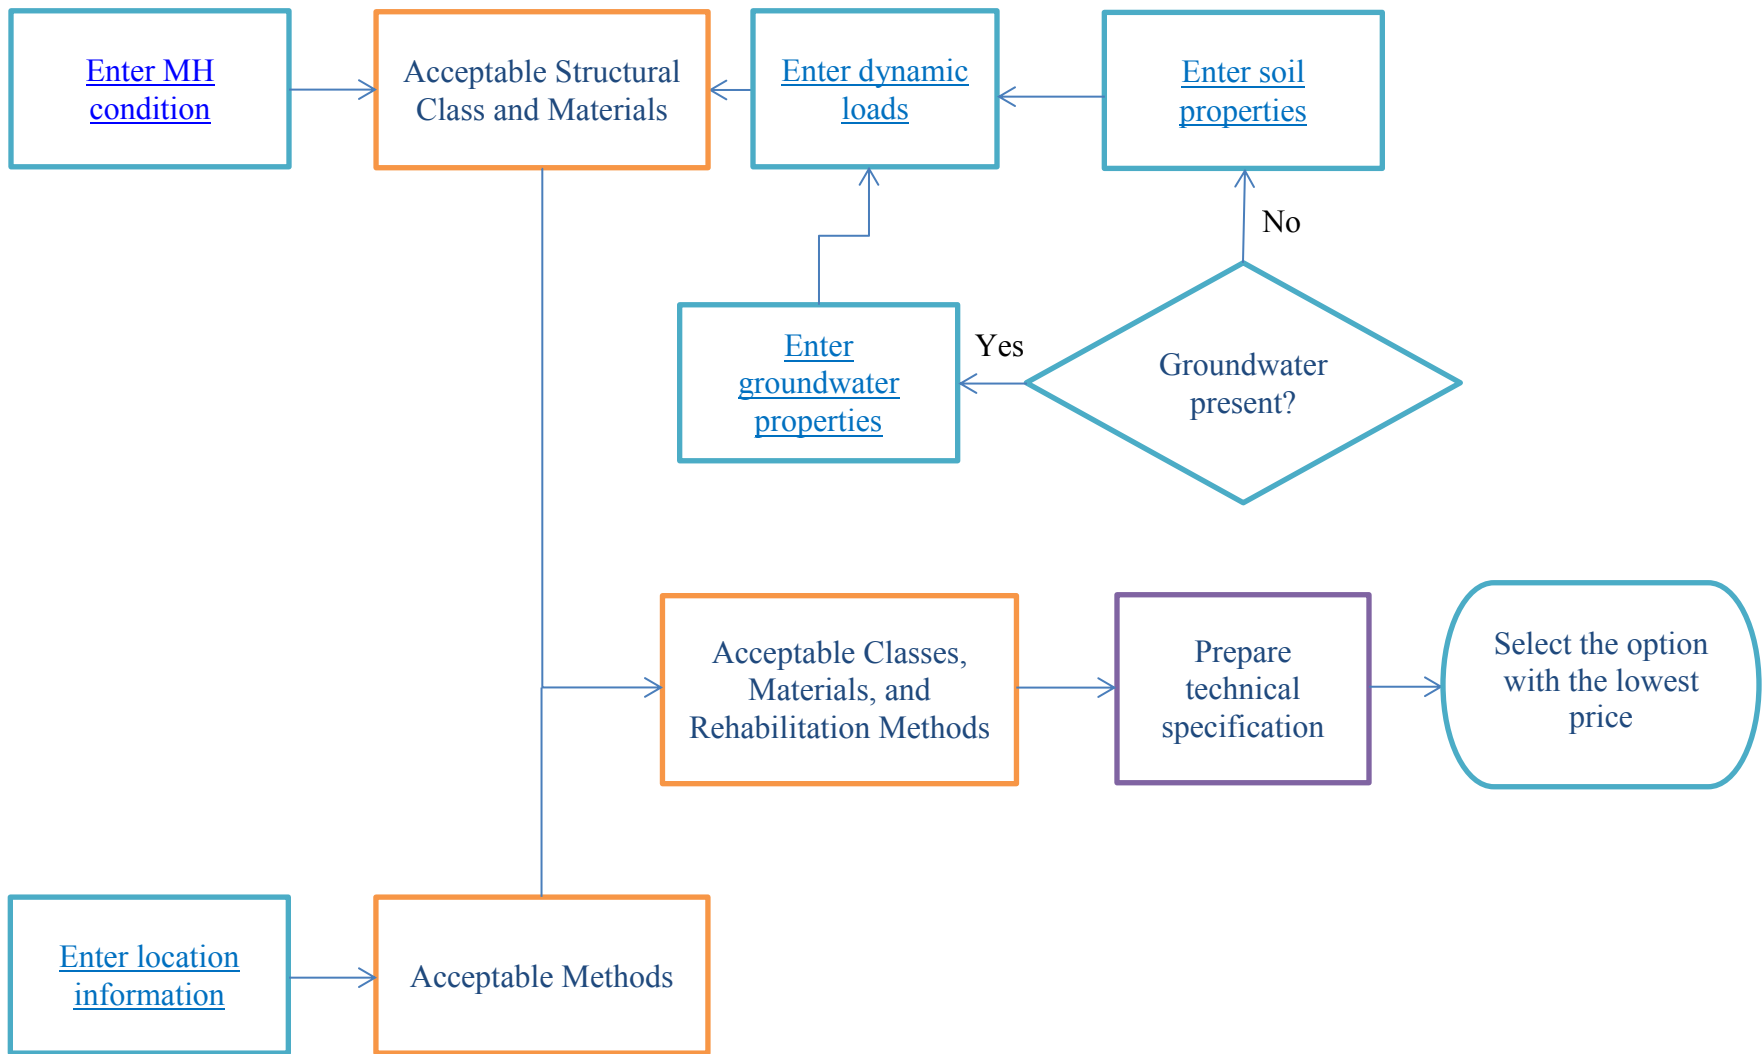
Figure 7-1. Logic Diagram for the Manhole Rehabilitation Decision Support Tool (DST).

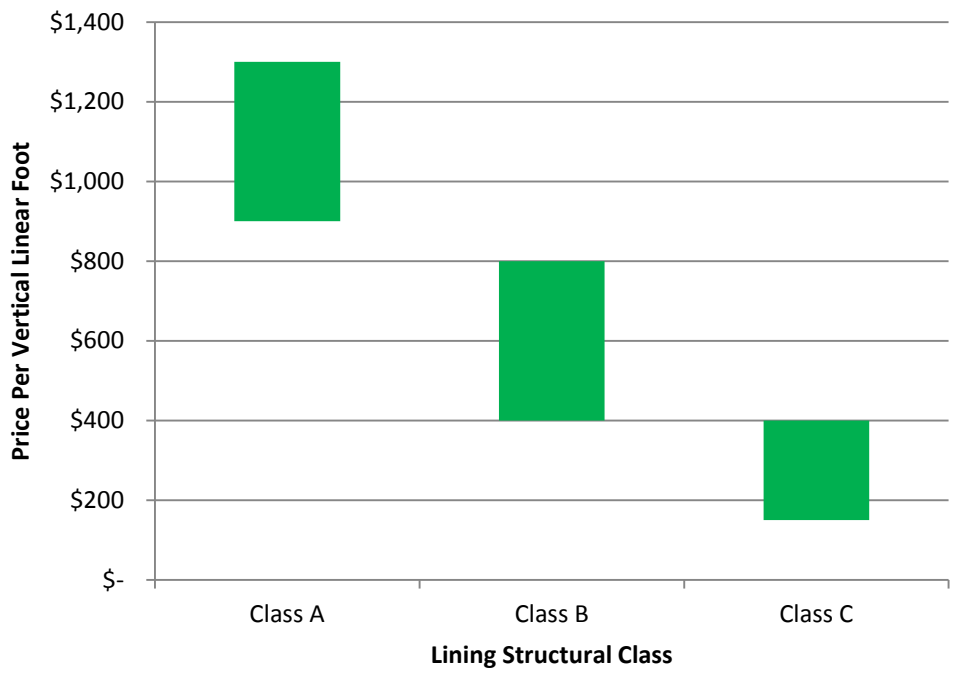
Figure 7-4. Price of Rehabilitation by Lining with Respect to the Structural Class of Rehabilitation Materials.

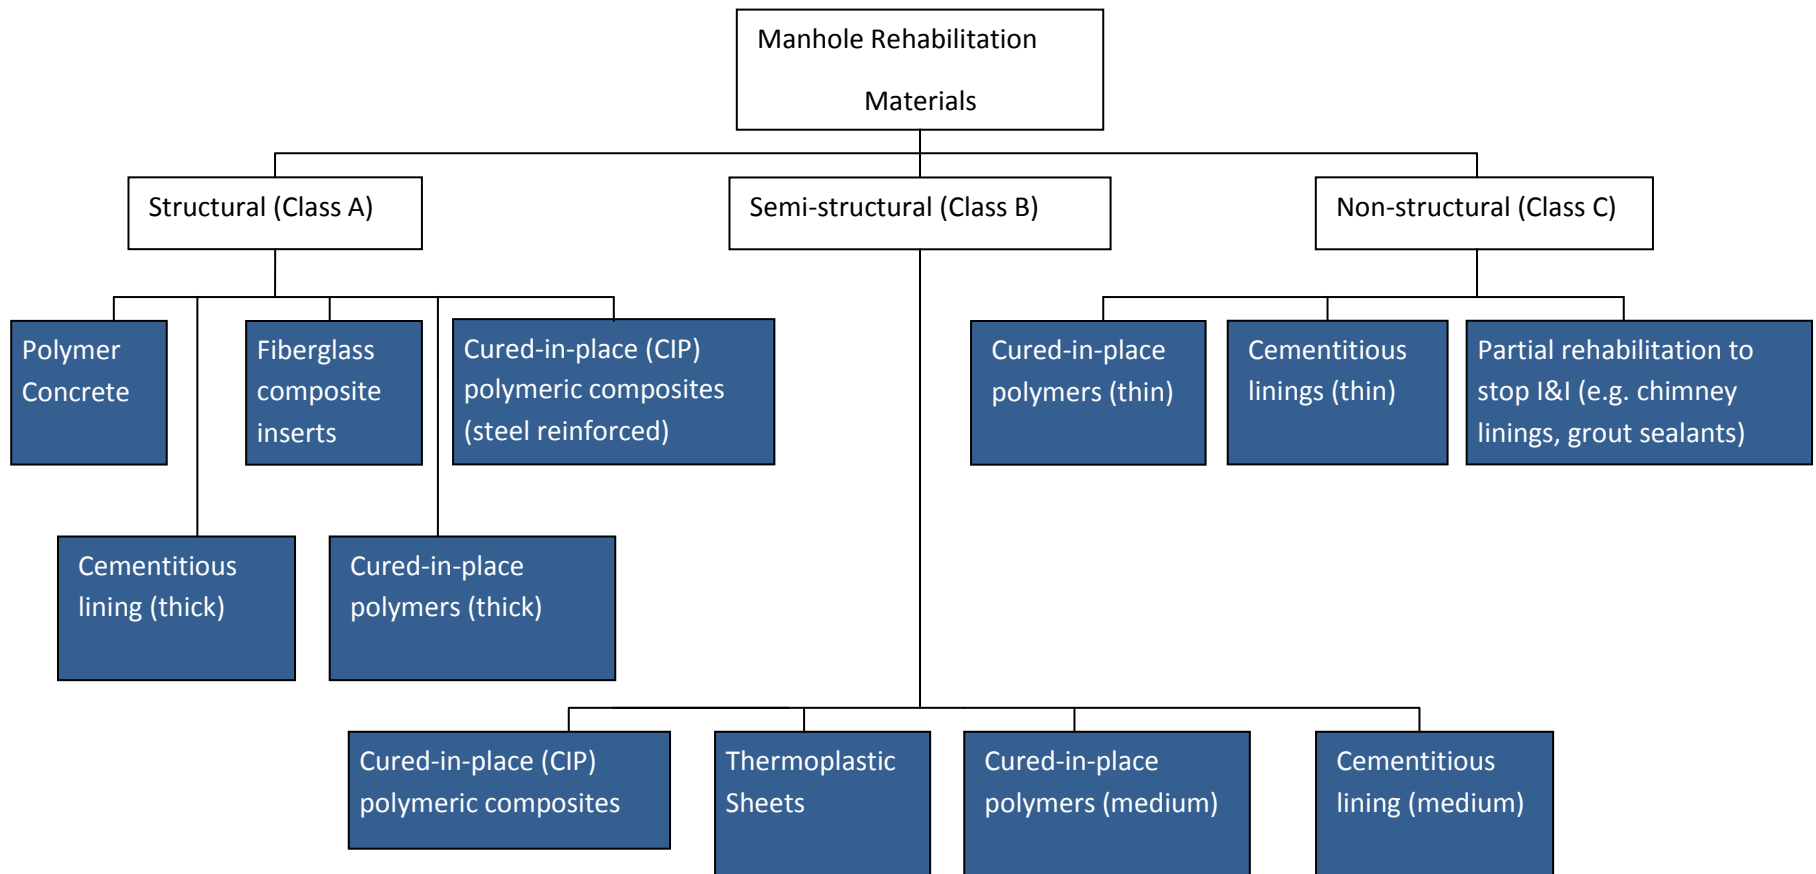
Figure 8-1. Manhole Rehabilitation Material Classification Based on Structural Capabilities.

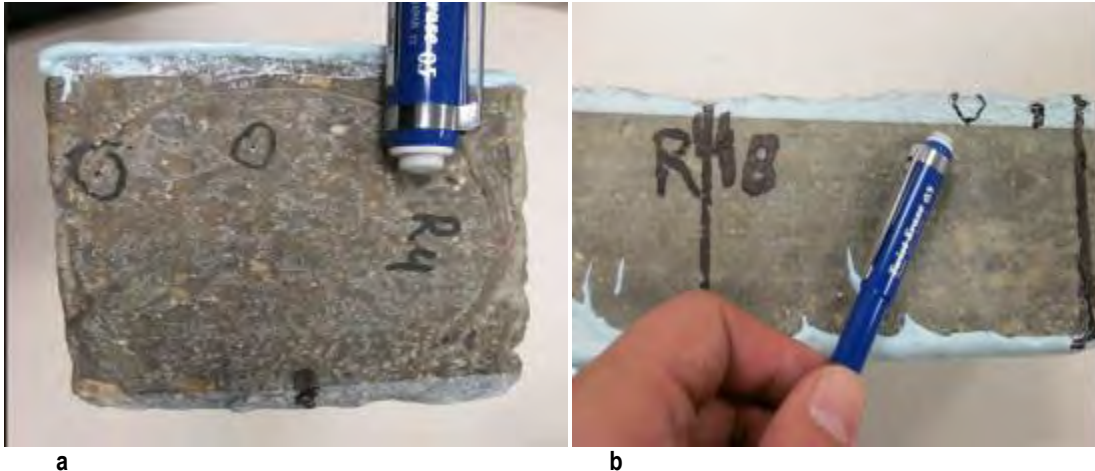
Figure C-6. Pinholes in the Concrete Substrate (a) and Liner (b).

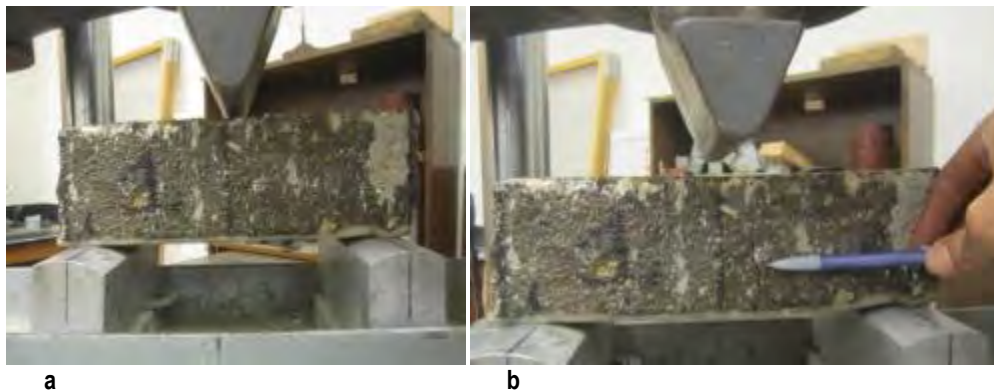
Figure C-9. Specimen Setup (a) and CIP-F#1 at Failure (b).

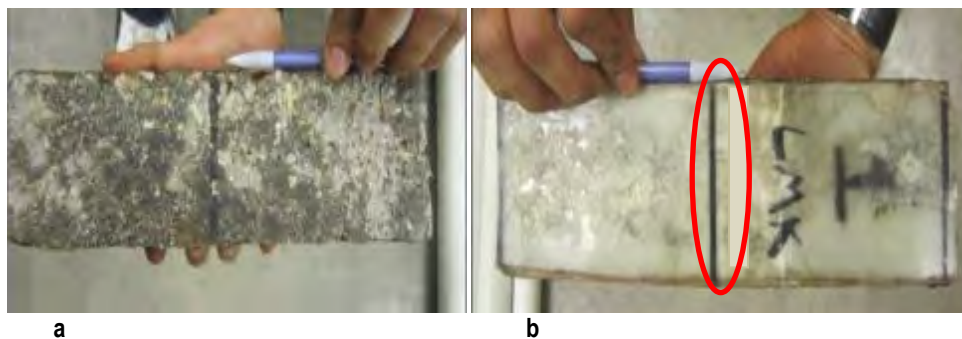
Figure C-10. CIP-F#1 Top Surface Without Any Cracks After Failure (a). Crack Along the Liner on the Bottom Surface of the Specimen (b).

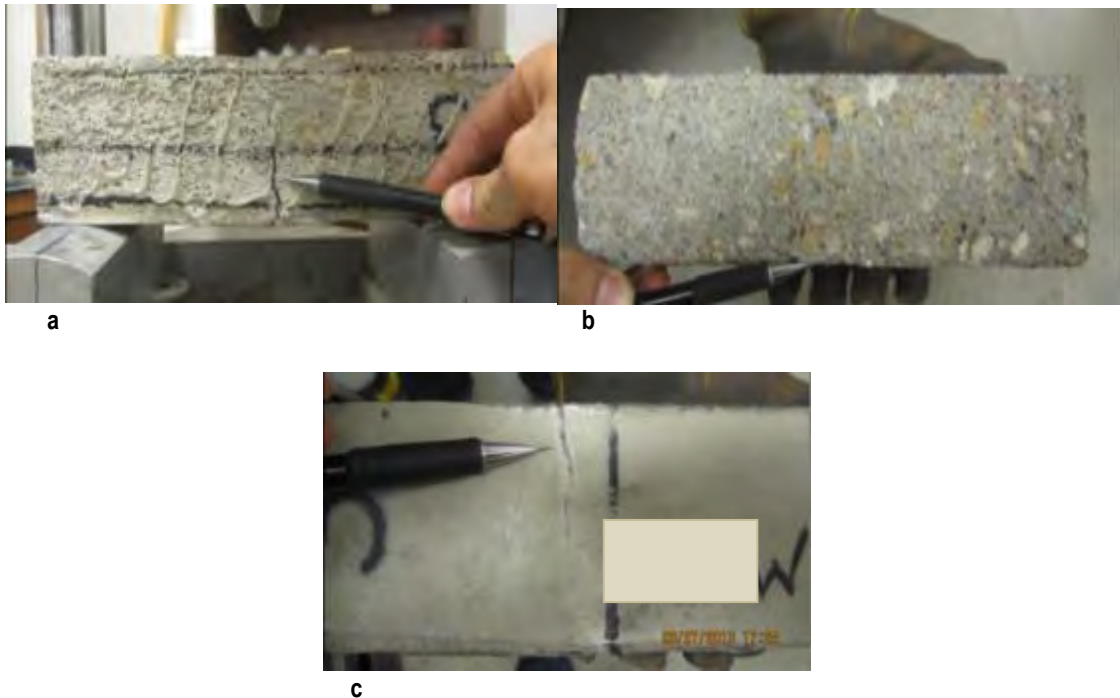
Figure C-12. Specimen CIP-F#3 at Failure (a).
Top View After Failure (No Visible Cracks on the Concrete) (b).
Fracture on the Liner (c).

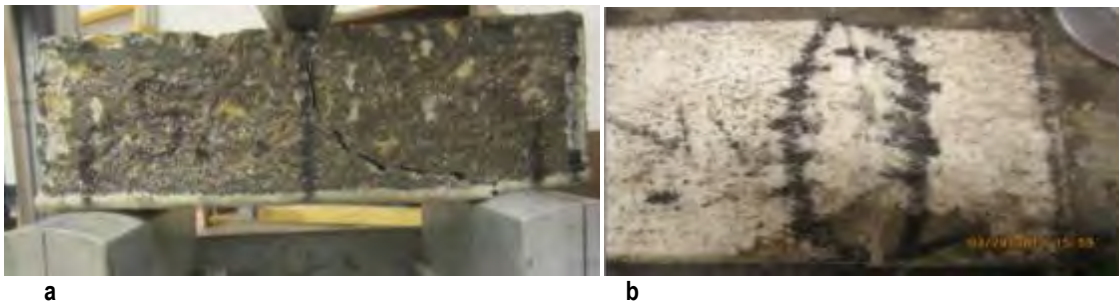
Figure C-14. Failure Plane in CIP-F#5(a) and Fracture Along the Liner (b).

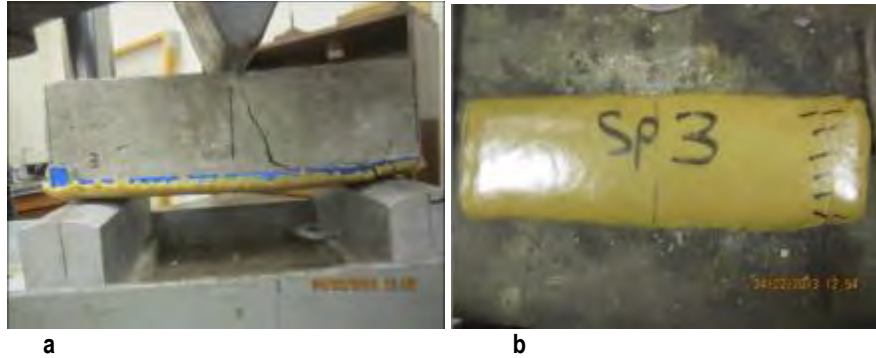
Figure C-17. Fracture in the Concrete Substrate (a) and PU-F#3 Liner Failure at the Support (b).

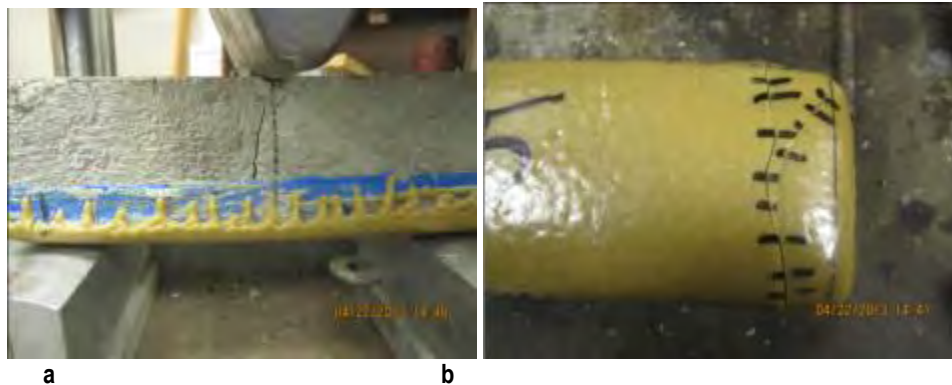
Figure C-18. Fracture in the Concrete Substrate (a) and PU-F#5 Liner Failure at the Support (b).

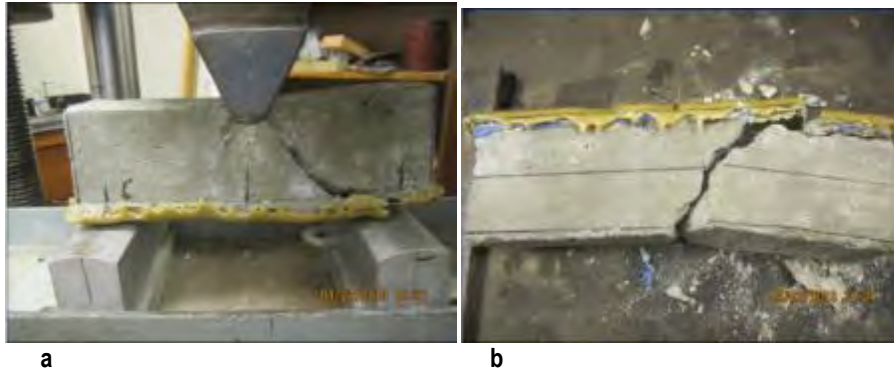
Figure C-19. Specimen PU-F#6 at Failure (a) with a Thin Section Separating Near the Support (b).

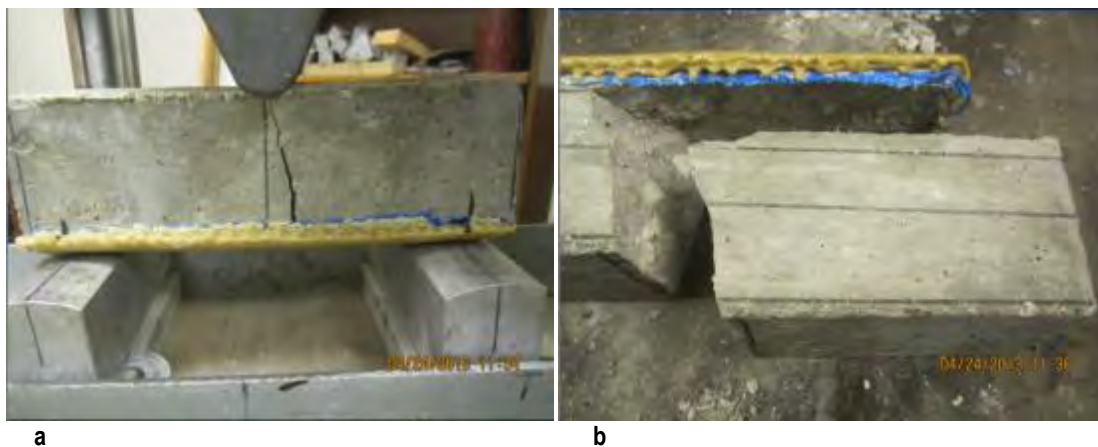
Figure C-20. Specimen PU-F#7 at Failure (a) and Detached Liner from the Concrete Substrate upon Failure.

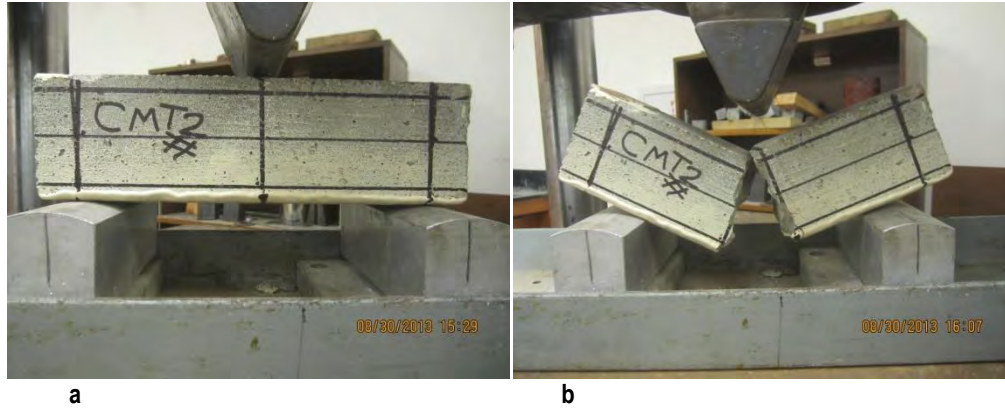
Figure C-23. Specimen CMP-F#2 Mounted on the Flexure Test Setup (a) and at Failure (b).

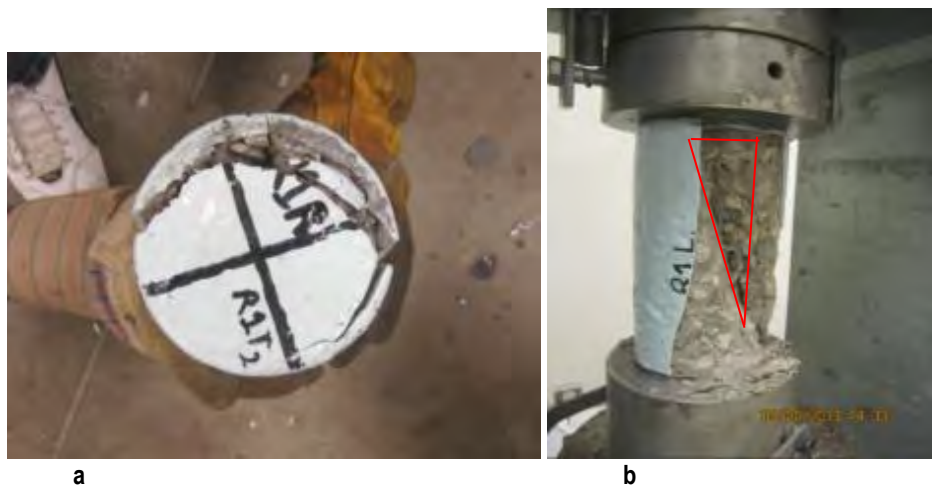
Figure C-28. Specimen EPX1-C#1 at Failure – Top View (a) and Side View (b).

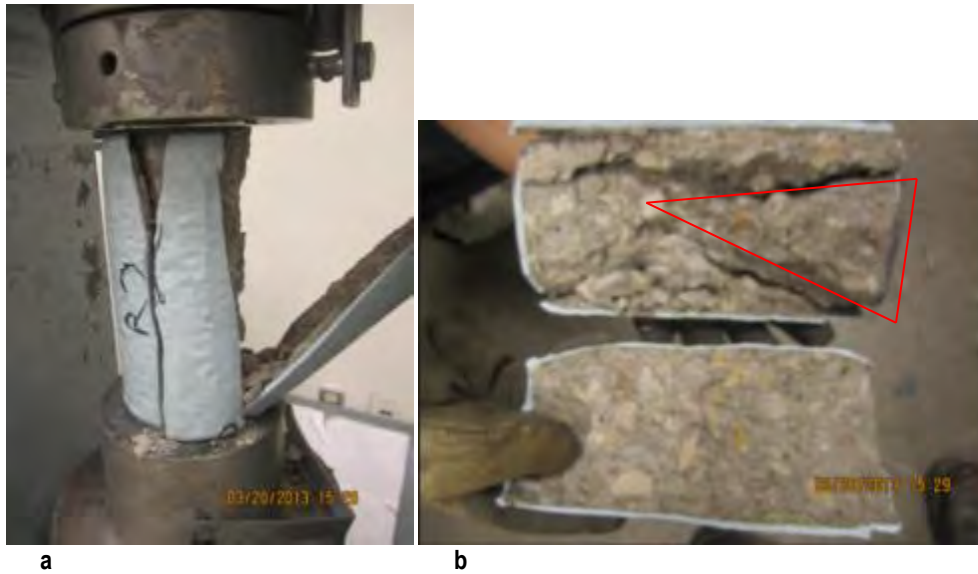
Figure C-29. Specimen EPX1-C#2 at Failure (a) with a Cone-Shaped Fracture Pattern in the Concrete Core (b).

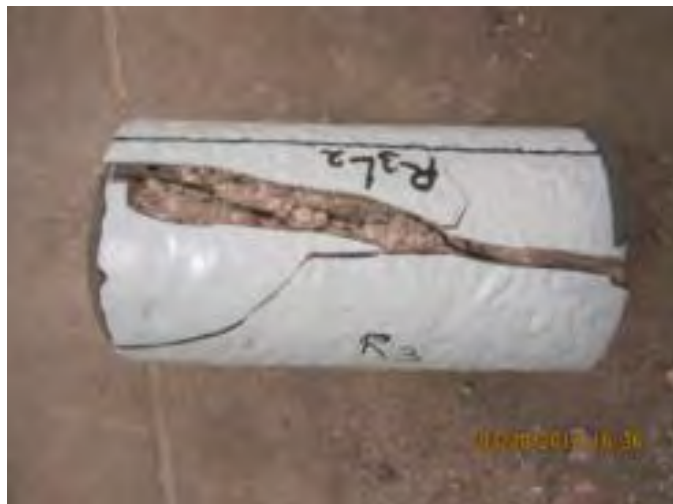
Figure C-30. Specimen EPX1-C#3 Failure Pattern.

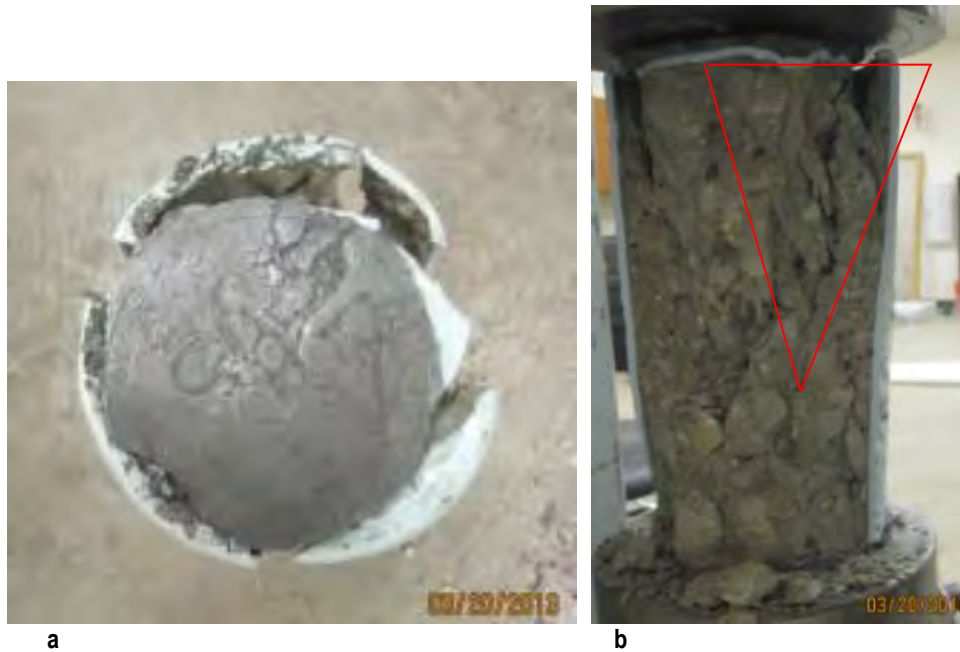
Figure C-31. Specimen EPX1-C#4 at Failure (a) with a Cone-Shaped Fracture Pattern in the Concrete Core (b).

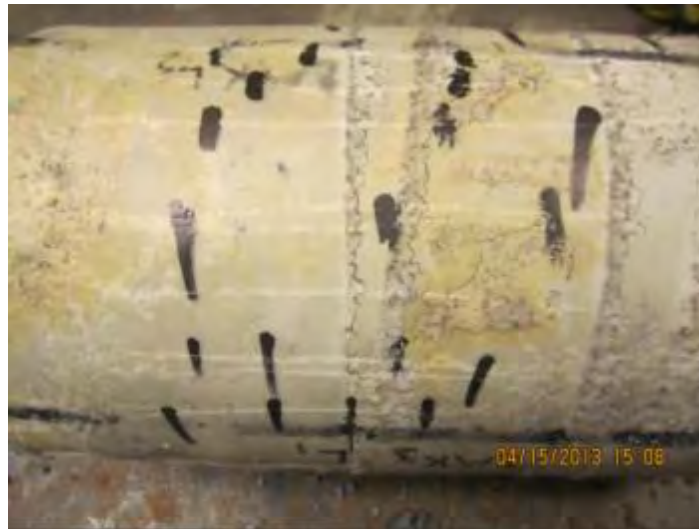
Figure C-36. Specimen CIP-C#3 at Failure, Note the Hairline Cracking.

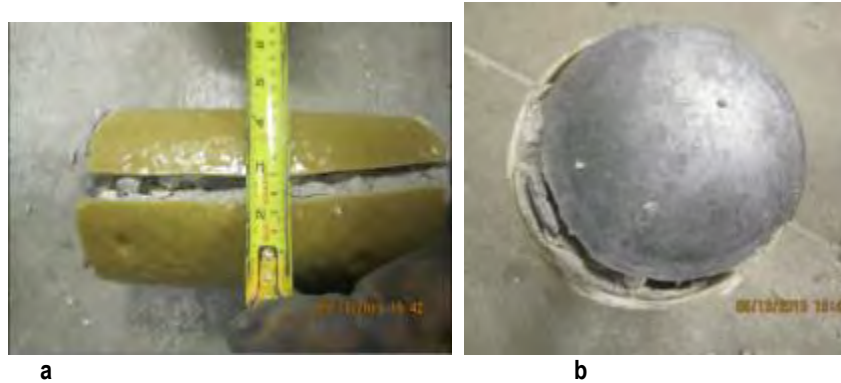
Figure C-41. A 3/4 -Inch (19 mm)-Wide Vertical Fracture Formed at Failure on PU-C#2 (a). The Liner Detached from the Substrate at this Location (b).

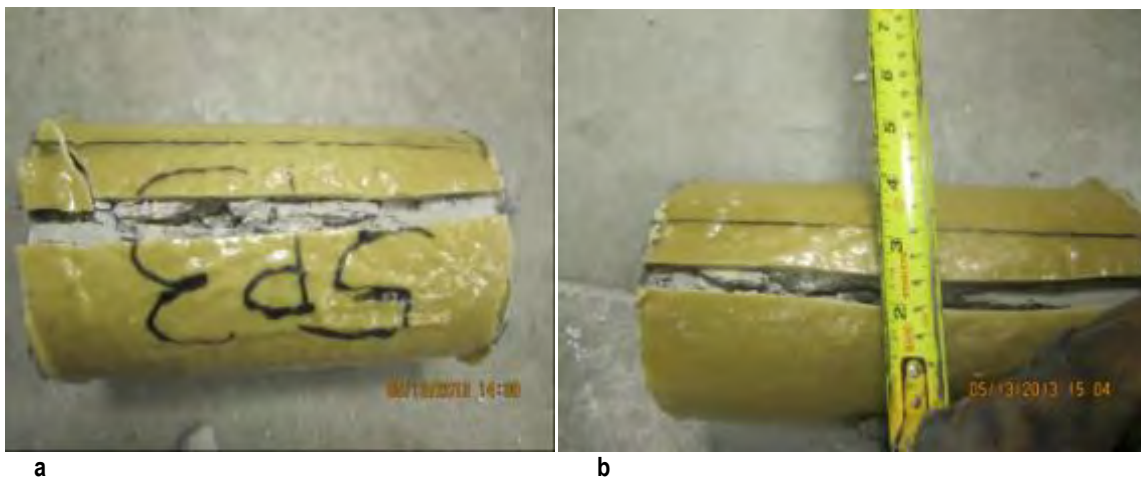
Figure C-42. Vertical Fracture in PU-C#3 (a) and PU-C#4 (b).
