AMERICAN
STRUCTUREPOINT
INC.

CASE STUDY

BARN COLLAPSE; WHEN EXPERIENCE IS NOT ON YOUR SIDE

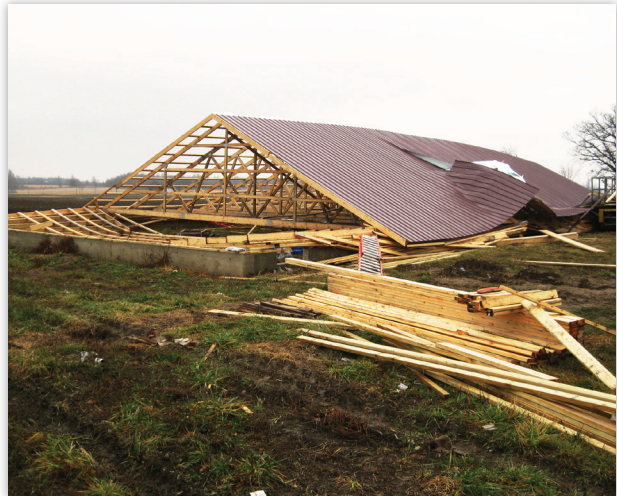
The forensic structural engineers at American Structurepoint were retained to determine the cause of the collapse of an agricultural barn under construction and identify possible subrogation opportunities. The owner of the barn was using the services of a construction company owned by his longtime friend. Expectedly, the contractor quickly claimed to be well seasoned in the field with decades of experience. There is no doubt he has completed numerous successful construction projects for many happy customers.

Even though the collapse of the barn occurred during an atypical November thunderstorm, a brief view of the barn collapse debris revealed the mode of failure was not solely the result of elevated wind speeds. According to the National Weather Service, the moderately severe storm produced a maximum sustained wind speed of 36 mph and maximum wind gusts up to 45 mph from the west, as recorded approximately 10 miles southeast of the property in rural northeast Indiana. These wind speeds are common in the region and are typically achieved several times each year.
